DEPARTMENT OF TRANSPORTATION

Office of Structural Materials

Contract #: 04-0120F4Cty: SF/ALA Rte: 80 PM: 13.2/13.9File #: 69.28**WELDING INSPECTION REPORT****Resident Engineer:** Siegenthaler, Peter**Address:** 333 Burma Road**City:** Oakland, CA 94607**Report No:** WIR-020103**Date Inspected:** 24-Dec-2010**Project Name:** SAS Superstructure**OSM Arrival Time:** 1500**Prime Contractor:** American Bridge/Fluor Enterprises, a JV**OSM Departure Time:** 300**Contractor:** Zhenhua Port Machinery Company, Ltd (ZPMC), Changxing Island **Location:** Shanghai, China**CWI Name:** Mr. Yu Jiao (ABF)**CWI Present:** Yes No**Inspected CWI report:** Yes No N/A**Rod Oven in Use:** Yes No N/A**Electrode to specification:** Yes No N/A**Weld Procedures Followed:** Yes No N/A**Qualified Welders:** Yes No N/A**Verified Joint Fit-up:** Yes No N/A**Approved Drawings:** Yes No N/A**Approved WPS:** Yes No N/A**Delayed / Cancelled:** Yes No N/A**Bridge No:** 34-0006**Component:** BAY 14 OBG**Summary of Items Observed:**

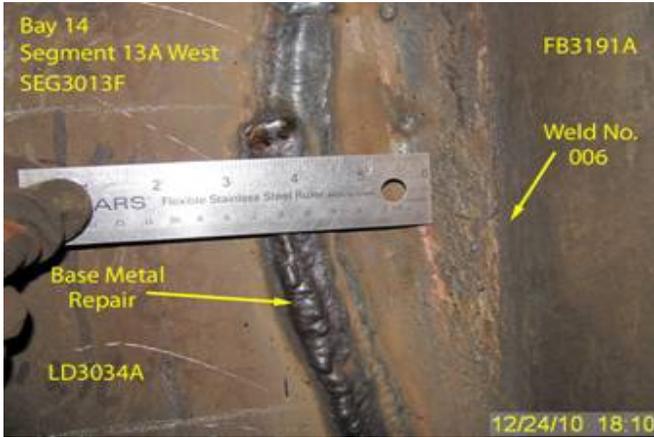
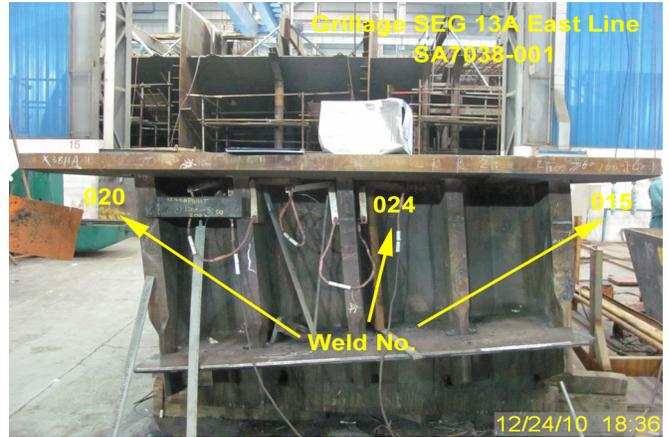
The connection plate (X3811A) to the Grillage Plate A (X3788A, 3787A, X3786A) Partial Joint Penetration corner welds with root openings between 9mm to 11mm in a total of three (3) locations. -The welds are designated as SA7038-015, 020 and 024. The welds are designated on the contract drawings as Seismic Performance Critical Members (SPCM).

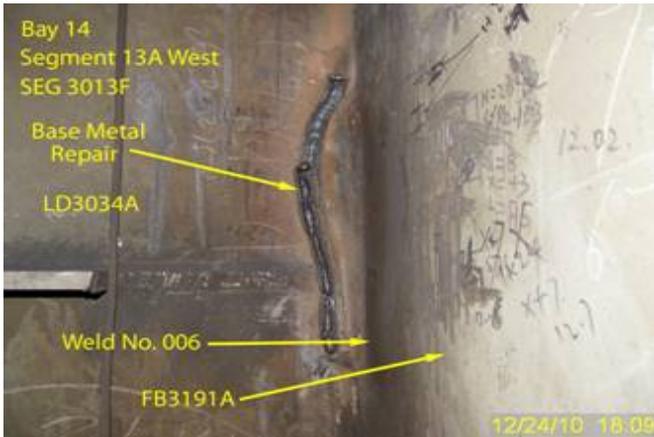
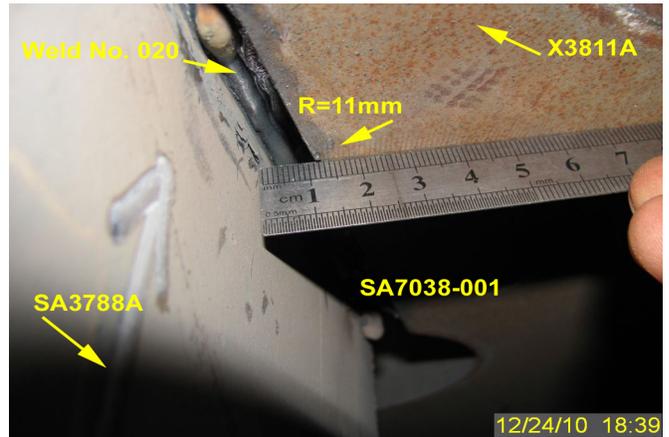
ZPMC personnel performing base metal repair on the Longitudinal Diaphragm (LD3034) web at W3, panel point 119 +1500 of Segment 13AW without the Engineer’s approval. Repairs were being performed adjacent to the Vertical web splice identified as LD3034-003 and floor beam to LD weld identified as SEG3013F-006.

-The material utilized is A709 Grade 345 SPCM.

-The welding process used was SMAW.
