DEPARTMENT OF TRANSPORTATION

Quality Assurance and Source Inspection

Contract #: 04-0120F4Cty: SF/ALA Rte: 80 PM: 13.2/13.9File #: 99.28**WELDING INSPECTION REPORT****Resident Engineer:** Siegenthaler, Peter**Address:** 333 Burma Road**City:** Oakland, CA 94607**Report No:** WIR-020127**Date Inspected:** 28-Dec-2010**Project Name:** SAS Superstructure**OSM Arrival Time:** 700**Prime Contractor:** American Bridge/Fluor Enterprises, a JV**OSM Departure Time:** 1900**Contractor:** Zhenhua Port Machinery Company, Ltd (ZPMC) Chanxing Island**Location:** Shanghai, China

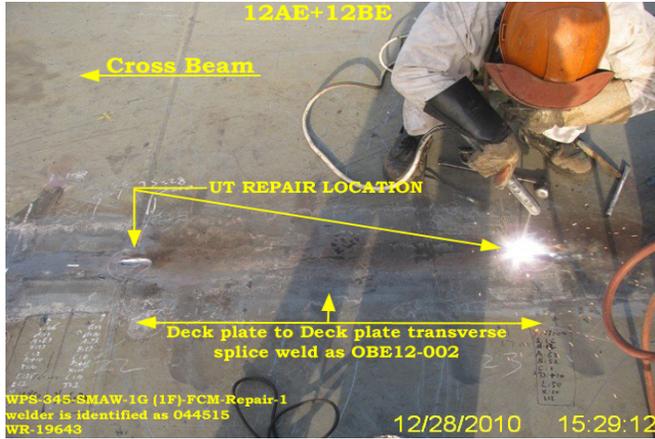
ZPMC welding personnel performing Shielded Metal Arc Welding (SMAW) of Repair weld for the deck plate to deck plate transverse splice weld joint located on 12AE+12BE. The weld is designated as OBE12-002. The welder is identified as 044515. ZPMC QC Mr. AN QING XING was onsite monitoring the welding variables. The inprocess SMAW appears to be progressing in compliance with WPS-345-SMAW-1G (1F)-FCM-Repair-1. The weld repair report number is named as WR-19643. Further weld detail mention in attached picture.
