**DEPARTMENT OF TRANSPORTATION**

Contract #: 04-0120F4Cty: SF/ALA Rte: 80 PM: 13.2/13.9File #: 99.28**WELDING INSPECTION REPORT****Resident Engineer:** Siegenthaler, Peter**Address:** 333 Burma Road**City:** Oakland, CA 94607**Report No:** WIR-020129**Date Inspected:** 30-Dec-2010**Project Name:** SAS Superstructure**OSM Arrival Time:** 700**Prime Contractor:** American Bridge/Fluor Enterprises, a JV**OSM Departure Time:** 1900**Contractor:** Zhenhua Port Machinery Company, Ltd (ZPMC) Chanxing Island**Location:** Shanghai, China**CWI Name:** Mr. LIU HUA JIE**CWI Present:** Yes No**Inspected CWI report:** Yes No N/A**Rod Oven in Use:** Yes No N/A**Electrode to specification:** Yes No N/A**Weld Procedures Followed:** Yes No N/A**Qualified Welders:** Yes No N/A**Verified Joint Fit-up:** Yes No N/A**Approved Drawings:** Yes No N/A**Approved WPS:** Yes No N/A**Delayed / Cancelled:** Yes No N/A**Bridge No:** 34-0006**Component:** OBG Segment**Summary of Items Observed:**

# WELDING INSPECTION REPORT

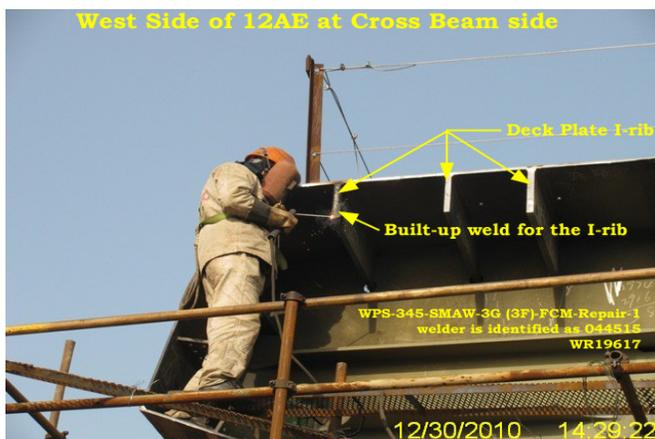
ZPMC welding personnel performing Shielded Metal Arc Welding (SMAW) of Built-up weld for the I-rib located on west side of 12AE at cross beam side. The welder is identified as 044515. ZPMC QC Mr. WANG LI YANG was onsite monitoring the welding variables. The inprocess SMAW appears to be progressing in compliance with WPS-345-SMAW-3G (3F)-FCM-Repair-1. The weld repair report number is named as WR19617. Further weld detail mention in attached picture.
