DEPARTMENT OF TRANSPORTATION

Contract #: 04-0120F4Cty: SF/ALA Rte: 80 PM: 13.2/13.9File #: 69.28**WELDING INSPECTION REPORT****Resident Engineer:** Siegenthaler, Peter**Address:** 333 Burma Road**City:** Oakland, CA 94607**Report No:** WIR-020148**Date Inspected:** 24-Jan-2011**Project Name:** SAS Superstructure**OSM Arrival Time:** 1500**Prime Contractor:** American Bridge/Fluor Enterprises, a JV**OSM Departure Time:** 300**Contractor:** Zhenhua Port Machinery Company, Ltd (ZPMC), Changxing Island **Location:** Shanghai, China**CWI Name:** Mr. Yu Jiao (ABF)**CWI Present:** Yes No**Inspected CWI report:** Yes No N/A**Rod Oven in Use:** Yes No N/A**Electrode to specification:** Yes No N/A**Weld Procedures Followed:** Yes No N/A**Qualified Welders:** Yes No N/A**Verified Joint Fit-up:** Yes No N/A**Approved Drawings:** Yes No N/A**Approved WPS:** Yes No N/A**Delayed / Cancelled:** Yes No N/A**Bridge No:** 34-0006**Component:** BAY 14 OBG**Summary of Items Observed:**

OBG BAY 14

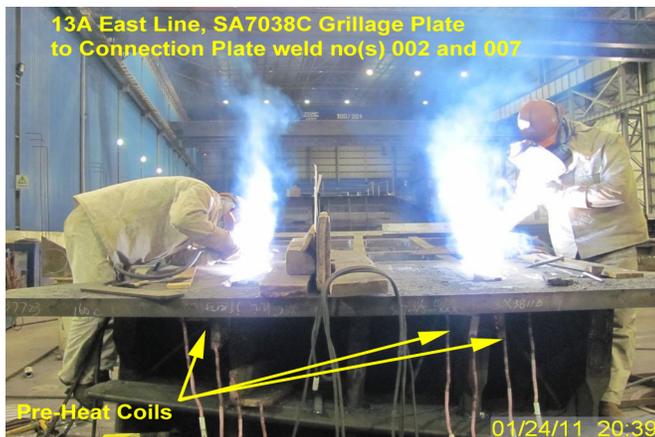
FCAW welding of complete joint penetration weld joint(s) located on lift 13A East Line, SA7038C Grillage Plate to Connection Plate weld number(s) 002 Welder is identified as welder no. 037723. The welding variables recorded by ZPMC QC identified as Zhan Hai Feng appeared to comply with applicable WPS(s) WPS-B-P-2231-ESAB.

FCAW welding of complete joint penetration weld joint(s) located on lift 13A East Line, SA7038C Grillage Plate to Connection Plate weld number(s) 007 Welder is identified as welder no. 066733. The welding variables recorded by ZPMC QC identified as Zhan Hai Feng appeared to comply with applicable WPS(s) WPS-B-P-2231-ESAB.

SMAW welding of complete joint penetration weld joint(s) located on lift 14 East Line SEG3019BB Vertical Shear Plate to Floor Beam Flange weld number(s) 059. Welder is identified as welder no. 215553. The welding variables recorded by ZPMC QC identified as Zhan Hai Feng appeared to comply with applicable WPS(s) WPS-B-P-2212-FCM-1.

SMAW welding of complete joint penetration weld joint(s) located on lift 14 East Line SEG3019BB Vertical Shear Plate to Floor Beam Flange weld number(s) 103. Welder is identified as welder no. 216086. The welding variables recorded by ZPMC QC identified as Zhan Hai Feng appeared to comply with applicable WPS(s) WPS-B-P-2212-FCM-1.

Unless otherwise noted, all work observed on this date appeared to generally comply with applicable contract documents.
