DEPARTMENT OF TRANSPORTATION

Contract #: 04-0120F4Cty: SF/ALA Rte: 80 PM: 13.2/13.9File #: 69.28**WELDING INSPECTION REPORT****Resident Engineer:** Siegenthaler, Peter**Address:** 333 Burma Road**City:** Oakland, CA 94607**Report No:** WIR-020278**Date Inspected:** 06-Feb-2011**Project Name:** SAS Superstructure**OSM Arrival Time:** 700**Prime Contractor:** American Bridge/Fluor Enterprises, a JV**OSM Departure Time:** 1900**Contractor:** Zhenhua Port Machinery Company, Ltd (ZPMC), Changxing Island **Location:** Shanghai, China**CWI Name:** Qiu Wen**CWI Present:** Yes No**Inspected CWI report:** Yes No N/A**Rod Oven in Use:** Yes No N/A**Electrode to specification:** Yes No N/A**Weld Procedures Followed:** Yes No N/A**Qualified Welders:** Yes No N/A**Verified Joint Fit-up:** Yes No N/A**Approved Drawings:** Yes No N/A**Approved WPS:** Yes No N/A**Delayed / Cancelled:** Yes No N/A**Bridge No:** 34-0006**Component:** OBG**Summary of Items Observed:**

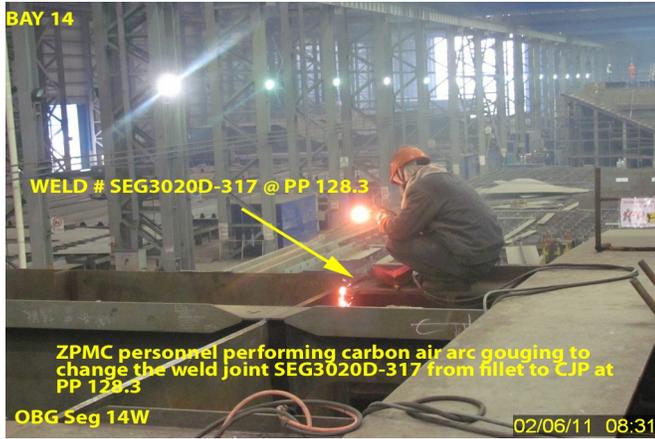
During random in process inspection this QA inspector observed that the weld joint SEG3020D-317, joining stiffener X8503A of Floor Beam (FB) 3343A to Longitudinal Diaphragm (LD) 3051A at Panel Point 128.3. This weld joint observed welded as a fillet weld. As per approved shop drawing this weld joint shown as Complete Joint Penetration (CJP) weld. This issue had been discussed with ZPMC CWI Mr. Qiu Wen, AB/F QA Mr. Xiao Jun Peng on 31st Jan 2011. This QA inspector observed that ZPMC personnel was performing carbon air arc gouging for excavation of fillet weld to change the weld joint as CJP. Attached photograph provide additional details.
