**DEPARTMENT OF TRANSPORTATION**

Contract #: 04-0120F4Cty: SF/ALA Rte: 80 PM: 13.2/13.9File #: 99.28**WELDING INSPECTION REPORT****Resident Engineer:** Siegenthaler, Peter**Address:** 333 Burma Road**City:** Oakland, CA 94607**Report No:** WIR-020335**Date Inspected:** 17-Dec-2010**Project Name:** SAS Superstructure**OSM Arrival Time:** 700**Prime Contractor:** American Bridge/Fluor Enterprises, a JV**OSM Departure Time:** 1900**Contractor:** Zhenhua Port Machinery Company, Ltd (ZPMC) Chanxing Island**Location:** Shanghai, China**CWI Name:** Mr. AN QIANG XING**CWI Present:** Yes No**Inspected CWI report:** Yes No N/A**Rod Oven in Use:** Yes No N/A**Electrode to specification:** Yes No N/A**Weld Procedures Followed:** Yes No N/A**Qualified Welders:** Yes No N/A**Verified Joint Fit-up:** Yes No N/A**Approved Drawings:** Yes No N/A**Approved WPS:** Yes No N/A**Delayed / Cancelled:** Yes No N/A**Bridge No:** 34-0006**Component:** OBG Segment**Summary of Items Observed:**

Orthotropic Box Girder (OBG) at Trial Assembly Area:

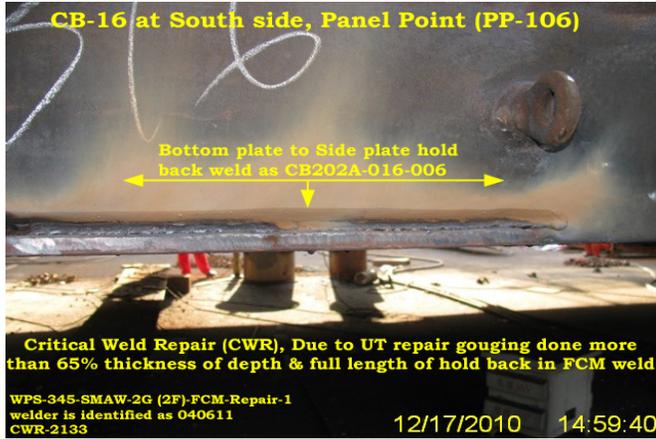
ZPMC welding personnel performing Shielded Metal Arc Welding (SMAW) of Repair weld for the bottom plate to side plate hold back weld joint located on CB-16 at south side, Panel Point (PP-106). The weld is designated as CB202A-016-006. The welder is identified as 040611. ZPMC QC Mr. ZHU YUAN YUAN was onsite monitoring the welding variables. The inprocess SMAW appears to be progressing in compliance with WPS-345-SMAW-2G (2F)-FCM-Repair-1. The weld repair report number is named as CWR-2133 Critical Weld Repair (CWR), Due to UT repair gouging done more than 65% thickness of depth & full length of hold back in FCM weld. Further weld detail mention in attached picture.
