**DEPARTMENT OF TRANSPORTATION**

Contract #: 04-0120F4Cty: SF/ALA Rte: 80 PM: 13.2/13.9File #: 1.28**WELDING INSPECTION REPORT****Resident Engineer:** Siegenthaler, Peter**Address:** 333 Burma Road**City:** Oakland, CA 94607**Report No:** WIR-020434**Date Inspected:** 09-Feb-2011**Project Name:** SAS Superstructure**OSM Arrival Time:** 800**Prime Contractor:** American Bridge/Fluor Enterprises, a JV**OSM Departure Time:** 1630**Contractor:** American Bridge/Fluor Enterprises, a JV**Location:** Job Site

# WELDING INSPECTION REPORT

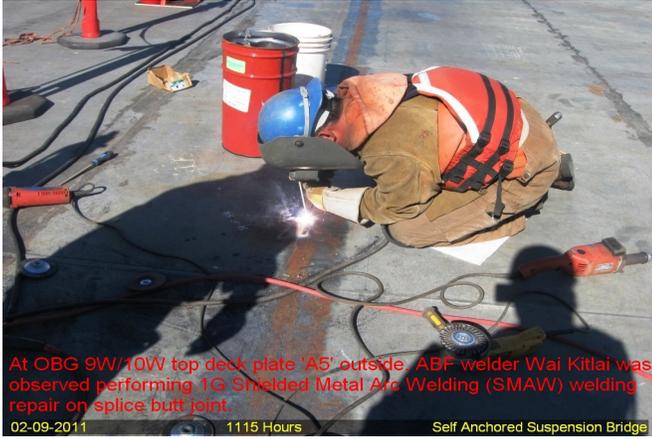
At OBG 9W/10W top deck plate 'A5' outside, QA randomly observed ABF/JV qualified welder Wai Kitlai perform CJP repair welding. The welder was noted welding in 1G (flat) position utilizing SMAW with 1/8" diameter E7018H4R electrode implementing new Caltrans approved Welding Procedure Specification (WPS) ABF-WPS-D15-1003 Repair. The new repair procedure includes putting in place a copper backing alongside the typical steel backing bar when the repair excavation is expected to occur at the edge of the steel backing. The welding repairs were excavated to a boat shape profile and were tested with Magnetic Particle Testing (MT) prior welding. During welding, ABF QC John Pagliero was noted monitoring the welder and his welding parameters. QA noted parameter during welding was 130 amperes which appears in compliance to the WPS. The locations of the repairs were noted below;

Location	Y-dimension	Length	Width	Depth	Remarks
1. A5	1140mm	110mm	20mm	15mm	Completed
2. A5	4120mm	120mm	22mm	20mm	Completed
