DEPARTMENT OF TRANSPORTATION

Contract #: 04-0120F4Cty: SF/ALA Rte: 80 PM: 13.2/13.9File #: 69.28**WELDING INSPECTION REPORT****Resident Engineer:** Siegenthaler, Peter**Address:** 333 Burma Road**City:** Oakland, CA 94607**Report No:** WIR-020514**Date Inspected:** 11-Feb-2011**Project Name:** SAS Superstructure**OSM Arrival Time:** 1500**Prime Contractor:** American Bridge/Fluor Enterprises, a JV**OSM Departure Time:** 300**Contractor:** Zhenhua Port Machinery Company, Ltd (ZPMC), Changxing Island **Location:** Shanghai, China**CWI Name:** Mr. Sha Zi**CWI Present:** Yes No**Inspected CWI report:** Yes No N/A**Rod Oven in Use:** Yes No N/A**Electrode to specification:** Yes No N/A**Weld Procedures Followed:** Yes No N/A**Qualified Welders:** Yes No N/A**Verified Joint Fit-up:** Yes No N/A**Approved Drawings:** Yes No N/A**Approved WPS:** Yes No N/A**Delayed / Cancelled:** Yes No N/A**Bridge No:** 34-0006**Component:** OBG**Summary of Items Observed:**

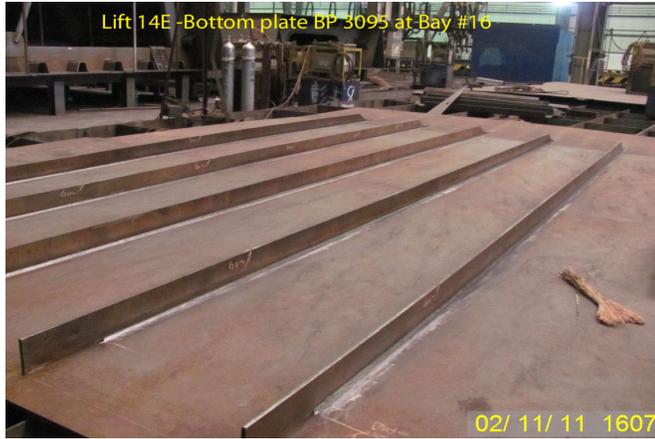
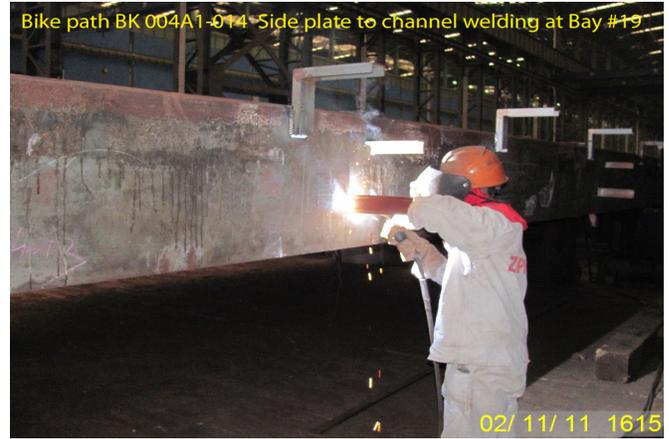
For further information see below pictures:-
