**DEPARTMENT OF TRANSPORTATION**

Contract #: 04-0120F4Cty: SF/ALA Rte: 80 PM: 13.2/13.9File #: 99.28**WELDING INSPECTION REPORT****Resident Engineer:** Siegenthaler, Peter**Address:** 333 Burma Road**City:** Oakland, CA 94607**Report No:** WIR-020544**Date Inspected:** 08-Feb-2011**Project Name:** SAS Superstructure**OSM Arrival Time:** 700**Prime Contractor:** American Bridge/Fluor Enterprises, a JV**OSM Departure Time:** 1900**Contractor:** Zhenhua Port Machinery Company, Ltd (ZPMC)**Location:** Shanghai, China

**Bridge No:** 34-0006**Component:** OBG Trial Assembly and Bay 14**Summary of Items Observed:**

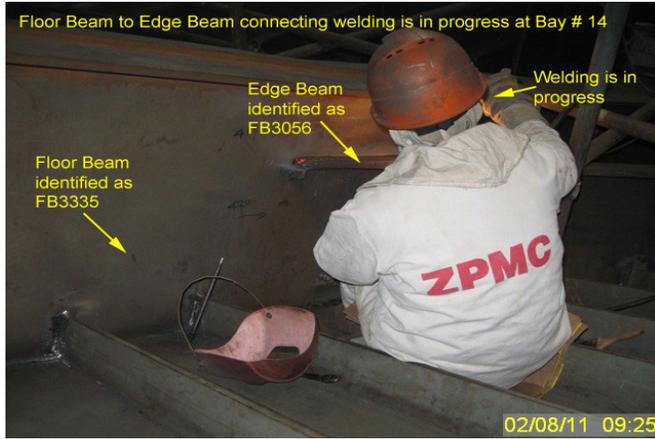
This QA Inspector observed the in-process welding by Flux Cored Arc Welding (FCAW) process on a Complete Joint Penetration (CJP) groove weld. The Weld joint was designated as Seg3020A2-419. The welder identification was 066421 and observed welding in the 2G(Horizontal) position using approved Welding Procedure Specification WPS-B-T-2232-ESAB. The piece mark was identified as the weld connecting the Floor Beam to the Edge Beam.

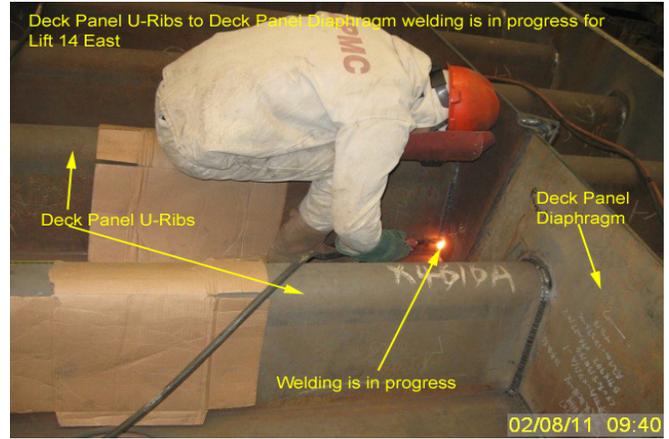
This QA Inspector observed the in-process welding by Flux Cored Arc Welding (FCAW) process on a Complete Joint Penetration (CJP) groove weld. The Weld joint was designated as SegDP3160-001-333. The welder identification was 066920 and observed welding in the 2G(Horizontal) position using approved Welding Procedure Specification WPS-B-T-2233-ESAB. The piece mark was identified as the weld connecting the Deck Panel U-Rib to Deck Panel Diaphragm.
