Contract #: 04-0120F4Cty: SF/ALA Rte: 80 PM: 13.2/13.9File #: 1.28**WELDING INSPECTION REPORT****Resident Engineer:** Siegenthaler, Peter**Address:** 333 Burma Road**City:** Oakland, CA 94607**Report No:** WIR-020558**Date Inspected:** 10-Feb-2011**Project Name:** SAS Superstructure**OSM Arrival Time:** 800**Prime Contractor:** American Bridge/Fluor Enterprises, a JV**OSM Departure Time:** 1630**Contractor:** American Bridge/Fluor Enterprises, a JV**Location:** Job Site

WELDING INSPECTION REPORT

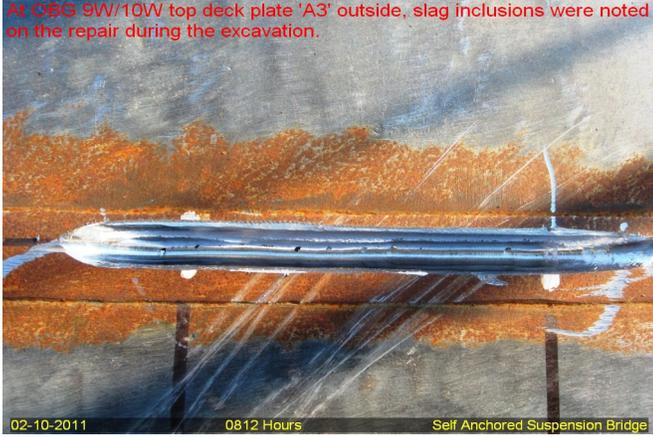
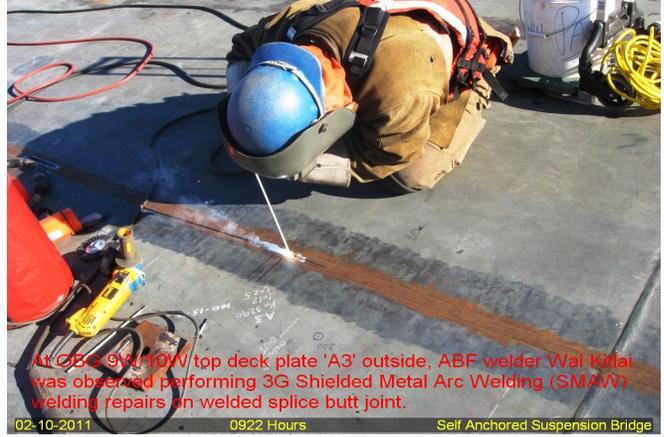
At OBG 9W/10W top deck plate 'A3' outside, QA randomly observed ABF/JV qualified welder Wai Kitlai perform CJP repair welding. The welder was noted welding in 1G (flat) position utilizing SMAW with 1/8" diameter E7018H4R electrode implementing new Caltrans approved Welding Procedure Specification (WPS) ABF-WPS-D15-1003 Repair. The new repair procedure includes putting in place a copper backing alongside the typical steel backing bar when the repair excavation is expected to occur at the edge of the steel backing. The welding repairs were excavated to a boat shape profile and were tested with Magnetic Particle Testing (MT) prior welding. During welding, ABF QC John Pagliero was noted monitoring the welder and his welding parameters. QA noted parameter during welding was 130 amperes which appears in compliance to the WPS. The locations of the repairs were noted below;

Location	Y-dimension	Length	Width	Depth	Remarks
1. A3	3260mm	100mm	15mm	14mm	Completed
2. A3	2040mm	200mm	20mm	14mm	Completed
3. A3	1540mm	85mm	20mm	15mm	Completed
4. A3	690mm	110mm	20mm	12mm	Completed

At OBG 9W/10W top deck plate 'A3' outside, slag inclusions were noted on the repair during the excavation.

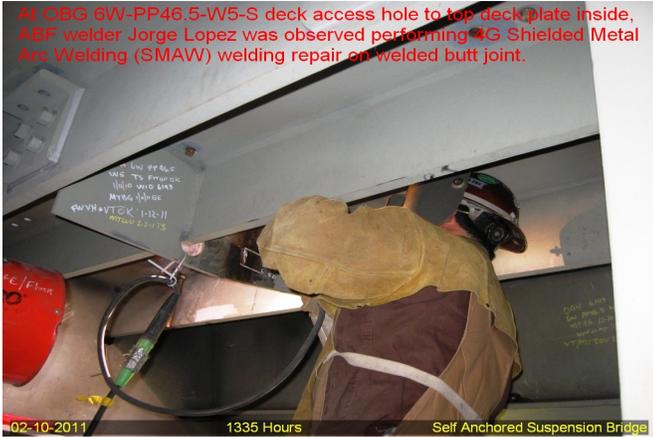
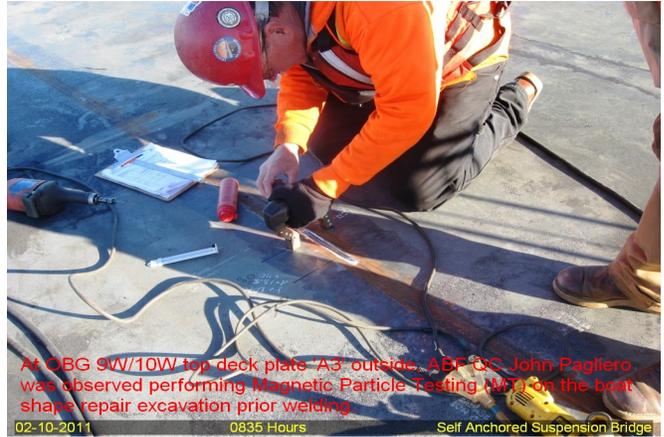
At OBG 6W-PP46.5-W5 deck access hole inside, QA randomly observed ABF/JV qualified welder Jorge Lopez perform CJP groove welding repair. The welder was observed welding in the 3G (vertical) & 4G (overhead) position utilizing Shielded Metal Arc Welding (SMAW) with 1/8" diameter E7018H4R electrode implementing welding procedure ABF-WPS-D15-1001-Repairs. The repair excavations were preheated to more than 140 degree Fahrenheit using propane gas torch prior welding. During the shift, ABF QC William Sherwood was noted monitoring the welder. Prior welding, ABF QC William Sherwood was also observed performing Magnetic Particle Testing (MT). The locations of the repairs were noted below;

Location	Y-dimension	Length	Width	Depth	Remarks
1. Transverse Stiffener	190mm	50mm	20mm	9mm	Completed
2. Deck Access Hole	85mm	70mm	23mm	9mm	Completed

At OBG 6W-PP46.5-W5-S deck access hole to top deck plate inside, ABF welder Jorge Lopez was observed performing 4G Shielded Metal Arc Welding (SMAW) welding repair on welded butt joint.
