DEPARTMENT OF TRANSPORTATION

Contract #: 04-0120F4Cty: SF/ALA Rte: 80 PM: 13.2/13.9File #: 99.28**WELDING INSPECTION REPORT****Resident Engineer:** Siegenthaler, Peter**Address:** 333 Burma Road**City:** Oakland, CA 94607**Report No:** WIR-020562**Date Inspected:** 14-Feb-2011**Project Name:** SAS Superstructure**OSM Arrival Time:** 700**Prime Contractor:** American Bridge/Fluor Enterprises, a JV**OSM Departure Time:** 1900**Contractor:** Zhenhua Port Machinery Company, Ltd (ZPMC)**Location:** Shanghai, China**CWI Name:** Li Yang and Zhu Zhong Hai**CWI Present:** Yes No**Inspected CWI report:** Yes No N/A**Rod Oven in Use:** Yes No N/A**Electrode to specification:** Yes No N/A**Weld Procedures Followed:** Yes No N/A**Qualified Welders:** Yes No N/A**Verified Joint Fit-up:** Yes No N/A**Approved Drawings:** Yes No N/A**Approved WPS:** Yes No N/A**Delayed / Cancelled:** Yes No N/A**Bridge No:** 34-0006**Component:** OBG Trial Assembly**Summary of Items Observed:**

Orthotropic Box Girder (OBG) at Trial Assembly Areas

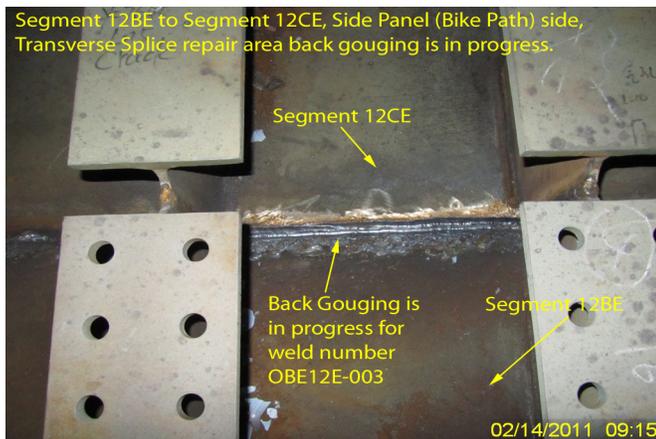
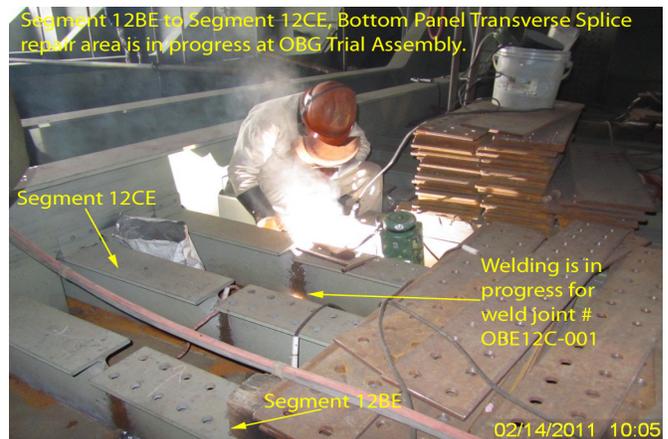
Segment 12BE to Segment 12CE (Bottom Panel, Transverse Splice weld)

This QA Inspector observed the repair welding by Shielded Metal Arc Welding (SMAW) process on a Complete Joint Penetration (CJP) groove weld. The Weld joint was designated as OBE12C-001. The welder identification was 044515 and 050289 and observed welding in the 1G (Flat) position using approved Welding Procedure Specification WPS-345-SMAW-1G(1F)-FCM-Repair-1. The piece mark was identified as the Bottom Panel, at transverse splice. ZPMC performed repair welding in accordance with Welding Repair Report B-WR20190.

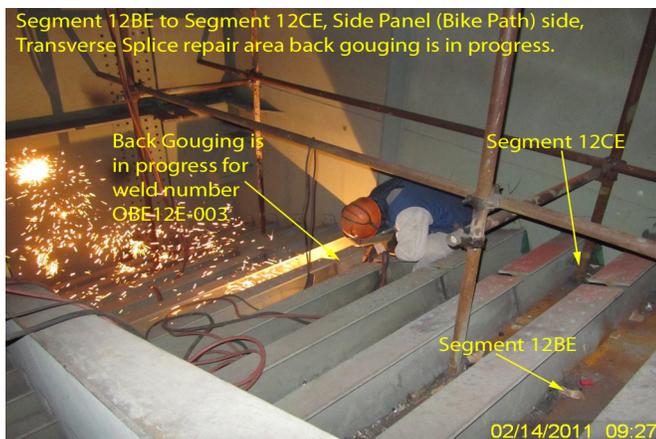
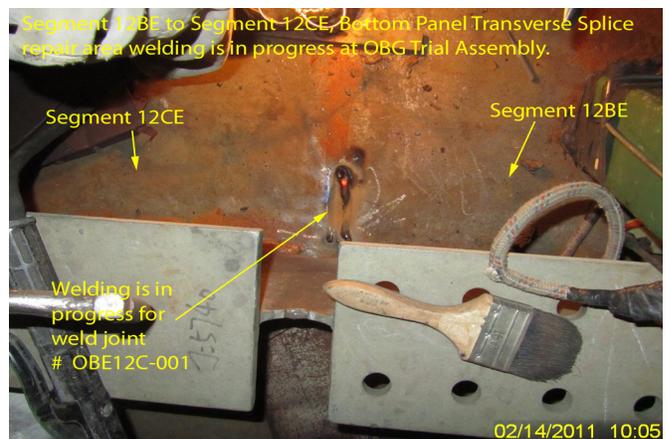
Segment 12BE to Segment 12CE (Transverse Splice weld)

This QA Inspector observed the back-gouging is in-process for the weld repair areas on the Complete Joint Penetration (CJP) groove weld. The Weld joint was designated as OBE12E-003. The welder identification was 040609. The piece mark was identified as the Side Panel, Bike Path side at transverse splice.
