**DEPARTMENT OF TRANSPORTATION**

Contract #: 04-0120F4Cty: SF/ALA Rte: 80 PM: 13.2/13.9File #: 69.28**WELDING INSPECTION REPORT****Resident Engineer:** Siegenthaler, Peter**Address:** 333 Burma Road**City:** Oakland, CA 94607**Report No:** WIR-020659**Date Inspected:** 16-Feb-2011**Project Name:** SAS Superstructure**OSM Arrival Time:** 700**Prime Contractor:** American Bridge/Fluor Enterprises, a JV**OSM Departure Time:** 1900**Contractor:** Zhenhua Port Machinery Company, Ltd (ZPMC), Changxing Island **Location:** Shanghai, China**CWI Name:** Shi Zhi, An Qing Xiang**CWI Present:** Yes No**Inspected CWI report:** Yes No N/A**Rod Oven in Use:** Yes No N/A**Electrode to specification:** Yes No N/A**Weld Procedures Followed:** Yes No N/A**Qualified Welders:** Yes No N/A**Verified Joint Fit-up:** Yes No N/A**Approved Drawings:** Yes No N/A**Approved WPS:** Yes No N/A**Delayed / Cancelled:** Yes No N/A**Bridge No:** 34-0006**Component:** OBG**Summary of Items Observed:**

## WELDING INSPECTION REPORT

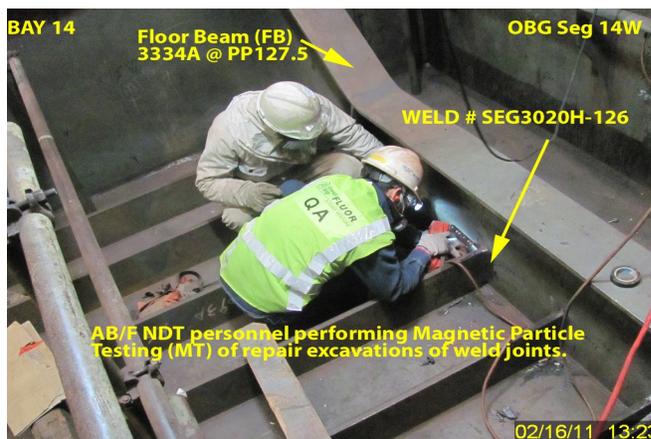
During random in process inspection this QA inspector observed that AB/F NDT personnel performing Magnetic Particle Testing of the excavated locations of weld joints rejected by ZPMC NDT personnel by Ultrasonic Testing (UT). The weld joints were identified as SEG3020H-126, 122, 130 joining I-rib stiffener on Bottom Plate (BP) 3093A to Floor Beam (FB) 3334A at Panel Point (PP) 127.5. Attached photograph provide additional details.
