**DEPARTMENT OF TRANSPORTATION**

Contract #: 04-0120F4Cty: SF/ALA Rte: 80 PM: 13.2/13.9File #: 99.28**WELDING INSPECTION REPORT****Resident Engineer:** Siegenthaler, Peter**Address:** 333 Burma Road**City:** Oakland, CA 94607**Report No:** WIR-020721**Date Inspected:** 14-Feb-2011**Project Name:** SAS Superstructure**OSM Arrival Time:** 700**Prime Contractor:** American Bridge/Fluor Enterprises, a JV**OSM Departure Time:** 1900**Contractor:** Zhenhua Port Machinery Company, Ltd (ZPMC) Chanxing Island**Location:** Shanghai, China**CWI Name:** Mr. Qui Wen**CWI Present:** Yes No**Inspected CWI report:** Yes No N/A**Rod Oven in Use:** Yes No N/A**Electrode to specification:** Yes No N/A**Weld Procedures Followed:** Yes No N/A**Qualified Welders:** Yes No N/A**Verified Joint Fit-up:** Yes No N/A**Approved Drawings:** Yes No N/A**Approved WPS:** Yes No N/A**Delayed / Cancelled:** Yes No N/A**Bridge No:** 34-0006**Component:** OBG Segment**Summary of Items Observed:**

# WELDING INSPECTION REPORT

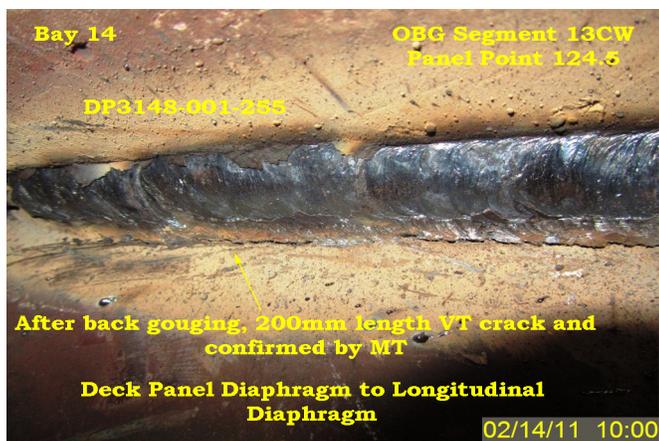
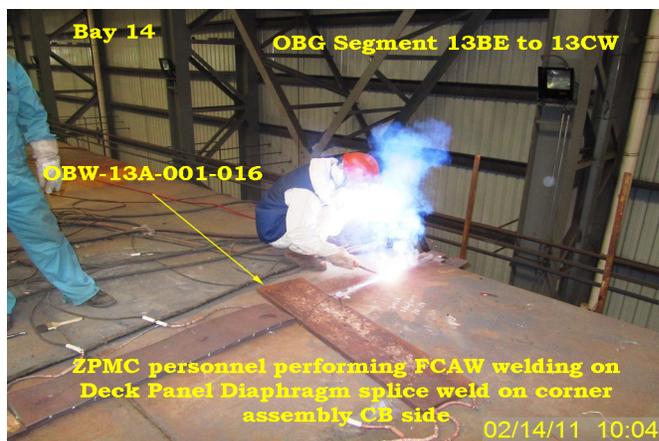
During the Quality Assurance random visual inspection of welds located on Floor beam (FL2)-deck panel diaphragm to Longitudinal Diaphragm welds of OBG Segment 13CW at panel point 124 and 124.5, this Quality Assurance Inspector (QA) observed the following issues;

- Linear Longitudinal Crack measuring approximately 200mm length.
- After back gouging, these indications were discovered visually and confirmed by Magnetic particle Testing (MT) by ZPMC MT personnel.
- The indications are clearly marked on the material near the weld for further repairs. The weld numbers are identified as DP3148-001-255 and DP3148-001-252. The panel point is identified as a PP124 and PP124.5 Counter Weight Side FL2.
- This weld is a CJP weld joining the Deck Panel Diaphragm to Longitudinal Diaphragm.
- The Deck Panel Diaphragm to Longitudinal Diaphragm weld is identified as Seismic Performance Critical Member (SPCM).
- The cracks are completely removed and re-weld shall be performed as per required contract document and approved CWR and WPS. For further information, Please see attached pictures.
