**DEPARTMENT OF TRANSPORTATION**

Contract #: 04-0120F4Cty: SF/ALA Rte: 80 PM: 13.2/13.9File #: 69.28**WELDING INSPECTION REPORT****Resident Engineer:** Siegenthaler, Peter**Address:** 333 Burma Road**City:** Oakland, CA 94607**Report No:** WIR-020800**Date Inspected:** 15-Feb-2011**Project Name:** SAS Superstructure**OSM Arrival Time:** 700**Prime Contractor:** American Bridge/Fluor Enterprises, a JV**OSM Departure Time:** 1900**Contractor:** Zhenhua Port Machinery Company, Ltd (ZPMC), Changxing Island **Location:** Shanghai, China**CWI Name:** Zhou Zhong Hai**CWI Present:** Yes No**Inspected CWI report:** Yes No N/A**Rod Oven in Use:** Yes No N/A**Electrode to specification:** Yes No N/A**Weld Procedures Followed:** Yes No N/A**Qualified Welders:** Yes No N/A**Verified Joint Fit-up:** Yes No N/A**Approved Drawings:** Yes No N/A**Approved WPS:** Yes No N/A**Delayed / Cancelled:** Yes No N/A**Bridge No:** 34-0006**Component:** OBG Segments**Summary of Items Observed:**

# WELDING INSPECTION REPORT

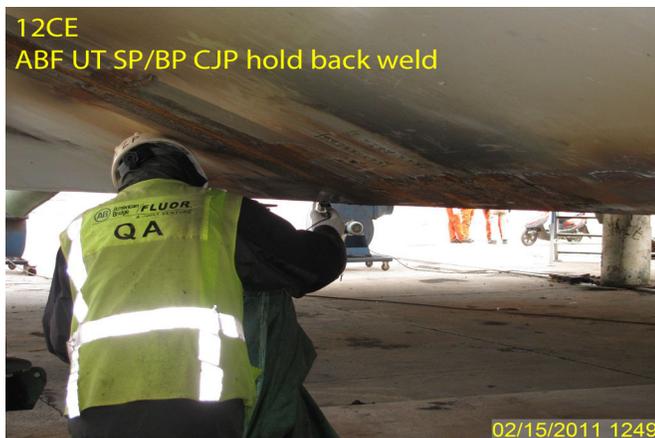
Unless otherwise noted, all work observed on this date appeared to generally comply with applicable contract documents.
