DEPARTMENT OF TRANSPORTATION

Contract #: 04-0120F4Cty: SF/ALA Rte: 80 PM: 13.2/13.9File #: 1.28**WELDING INSPECTION REPORT****Resident Engineer:** Siegenthaler, Peter**Address:** 333 Burma Road**City:** Oakland, CA 94607**Report No:** WIR-020847**Date Inspected:** 15-Feb-2011**Project Name:** SAS Superstructure**OSM Arrival Time:** 800**Prime Contractor:** American Bridge/Fluor Enterprises, a JV**OSM Departure Time:** 1630**Contractor:** American Bridge/Fluor Enterprises, a JV**Location:** Job Site

WELDING INSPECTION REPORT

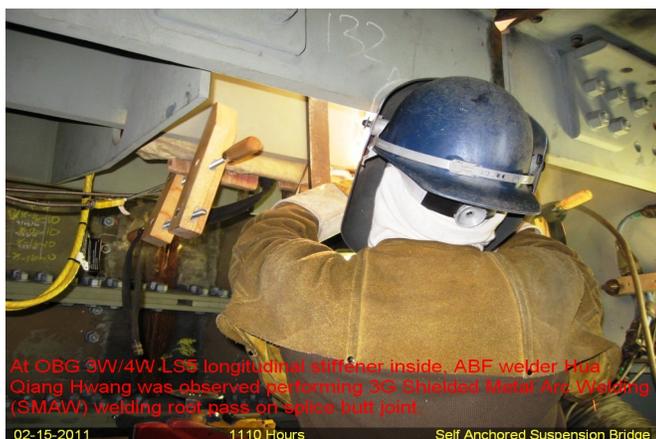
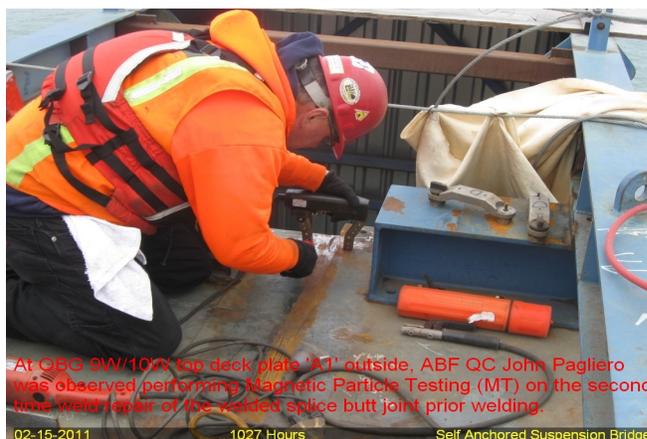
At OBG 3W/4W LS5 longitudinal stiffener inside, QA randomly observed ABF welder Hua Qiang Hwang ID #2930 perform 3G (vertical) SMAW back welding fill pass on the stiffener CJP splice butt joint. The joint has a double V joint preparation that was welded from one side using E9018H4R with 1/8" diameter electrode implementing Caltrans approved welding procedure specification (WPS) ABF-WPS-D1.5-1012-3. The joint being welded was root welded using a ceramic backing, fully welded from one side then back gouged and was ground smooth. The other side was back gouged and ground smooth and was also Non Destructive Testing (NDT) tested using the MT. The splice joint was preheated to greater than 200 degrees Fahrenheit using Miller Proheat 35 Induction Heating System located at the opposite side of the plate prior/during welding. QA noted the ABF QC Gary Ersham was on site monitoring the in process preheats and welding parameters. During the shift, QA noted ABF QC Gary Ersham was closely monitoring the issuance of E9018H4R electrodes due to its limited exposure time allowed. At the end of the shift, fill pass welding on the other side of the stiffener LS5 was still continuing and should remain tomorrow. The welder was also told to keep the preheat maintenance of more than 200 degrees Fahrenheit after welding and hold it for three hours as required.

At OBG 3W/4W LS3 longitudinal stiffener inside, QA randomly observed ABF welder Xiao Jian Wan perform 3G (vertical) SMAW back welding cover pass on the stiffener CJP splice butt joint. The joint has a double V joint preparation that was welded from one side using E9018H4R with 1/8" diameter electrode implementing Caltrans approved welding procedure specification (WPS) ABF-WPS-D1.5-1012-3. The joint being welded was root welded using a ceramic backing, fully welded from one side then back gouged and was ground smooth. The other side was back gouged and ground smooth and was also Non Destructive Testing (NDT) tested using the MT. The splice joint was preheated to greater than 200 degrees Fahrenheit using Miller Proheat 35 Induction Heating System located at the opposite side of the plate prior/during welding. QA noted the ABF QC Gary Ersham was on site monitoring the in process preheats and welding parameters. During the shift, QA noted ABF QC Gary Ersham was closely monitoring the issuance of E9018H4R electrodes due to its limited exposure time allowed. During the shift, cover pass welding on the other side of the stiffener LS3 was completed. The welder was also told to keep the preheat maintenance of more than 200 degrees Fahrenheit after welding and hold it for three hours as required.

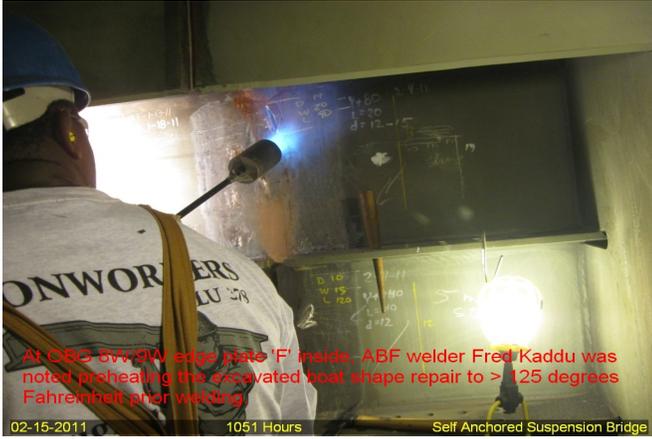
02-15-2011 1051 Hours Self Anchored Suspension Bridge

At OBG 3W/4W edge joints 'F' inside - ABF welder Fred Kaddu was noted preheating the excavated boat shape repair to > 125 degrees Fahrenheit prior welding.

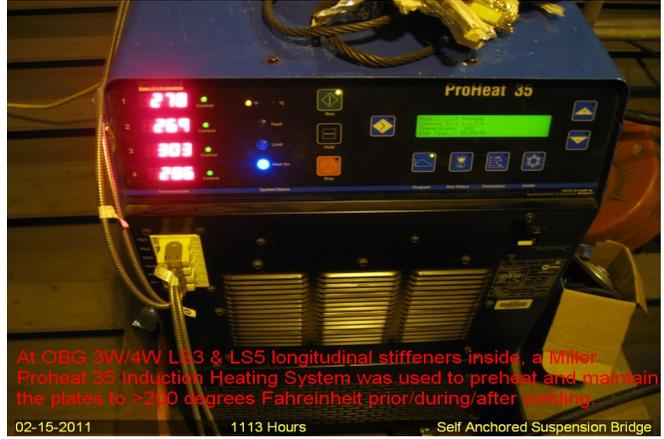
02-15-2011 1113 Hours Self Anchored Suspension Bridge

At OBG 3W/4W LS3 & LS5 longitudinal stiffeners inside, a Miller Proheat 35 Induction Heating System was used to preheat and maintain the plates to >200 degrees Fahrenheit prior/during/after welding.
