**DEPARTMENT OF TRANSPORTATION**

Quality Assurance and Source Inspection

Contract #: 04-0120F4Cty: SF/ALA Rte: 80 PM: 13.2/13.9File #: 1.28**WELDING INSPECTION REPORT****Resident Engineer:** Siegenthaler, Peter**Address:** 333 Burma Road**City:** Oakland, CA 94607**Report No:** WIR-020855**Date Inspected:** 11-Feb-2011**Project Name:** SAS Superstructure**OSM Arrival Time:** 800**Prime Contractor:** American Bridge/Fluor Enterprises, a JV**OSM Departure Time:** 1630**Contractor:** American Bridge/Fluor Enterprises, a JV**Location:** Jobsite**CWI Name:** See below**CWI Present:** Yes No**Inspected CWI report:** Yes No N/A**Rod Oven in Use:** Yes No N/A**Electrode to specification:** Yes No N/A**Weld Procedures Followed:** Yes No N/A**Qualified Welders:** Yes No N/A**Verified Joint Fit-up:** Yes No N/A**Approved Drawings:** Yes No N/A**Approved WPS:** Yes No N/A**Delayed / Cancelled:** Yes No N/A**Bridge No:** 34-0006**Component:** SAS OBG**Summary of Items Observed:**

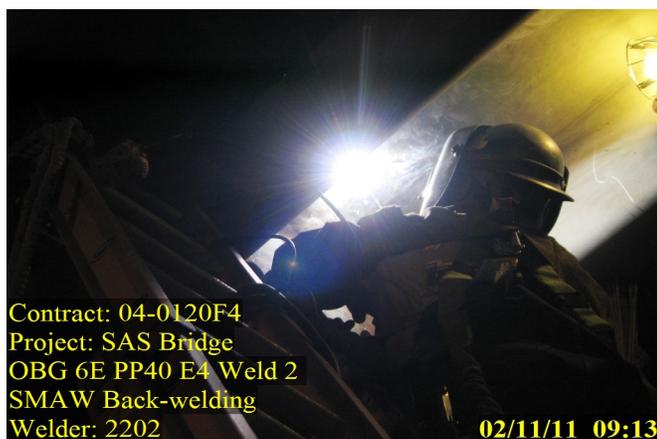
Interior: OBG 6E PP40 E4 welds 2 & 4

The QAI randomly observed AB/F approved welder Salvador Sandoval (ID 2202) performing back-welding per the Shielded Metal Arc Welding (SMAW) process in the 4G (overhead) position on the interior surface of OBG 6E PP40 E4 welds 2 & 4. See photo below. QC Inspector Steve McConnell was present to monitor the progress and verify that the welding parameters were within the limits established by the approved welding Procedure Specification (WPS) identified as ABF-WPS-D1.5-1110B rev 1. The QAI observed that work was in process at

this location and appeared to be in general compliance with contract documents.

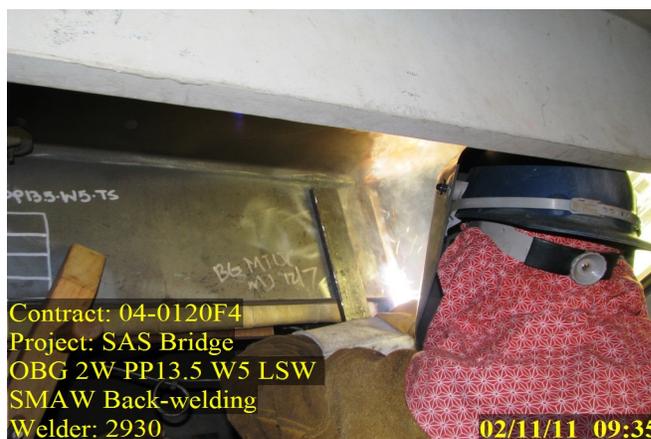
LSW

The QAI periodically observed AB/F approved welder Hua Qiang Hwang (ID 2930) performing back-welding per the Shielded Metal Arc Welding (SMAW) process in the 3G (vertical) position on the North face of LSW. See photo below. QC Inspector Gary Ehram was present to monitor the progress and verify that the welding parameters were within the limits established by the approved welding Procedure Specification (WPS) identified as ABF-WPS-D1.5-1012-3. The welding was completed and the QAI observed that the work at this location appeared to be in general compliance with contract documents.
