DEPARTMENT OF TRANSPORTATION

Contract #: 04-0120F4Cty: SF/ALA Rte: 80 PM: 13.2/13.9File #: 69.28**WELDING INSPECTION REPORT****Resident Engineer:** Siegenthaler, Peter**Address:** 333 Burma Road**City:** Oakland, CA 94607**Report No:** WIR-020875**Date Inspected:** 19-Feb-2011**Project Name:** SAS Superstructure**OSM Arrival Time:** 1500**Prime Contractor:** American Bridge/Fluor Enterprises, a JV**OSM Departure Time:** 300**Contractor:** Zhenhua Port Machinery Company, Ltd (ZPMC), Changxing Island **Location:** Shanghai, China**CWI Name:** See Below**CWI Present:** Yes No**Inspected CWI report:** Yes No N/A**Rod Oven in Use:** Yes No N/A**Electrode to specification:** Yes No N/A**Weld Procedures Followed:** Yes No N/A**Qualified Welders:** Yes No N/A**Verified Joint Fit-up:** Yes No N/A**Approved Drawings:** Yes No N/A**Approved WPS:** Yes No N/A**Delayed / Cancelled:** Yes No N/A**Bridge No:** 34-0006**Component:** OBG & Tower**Summary of Items Observed:**

WELDING INSPECTION REPORT

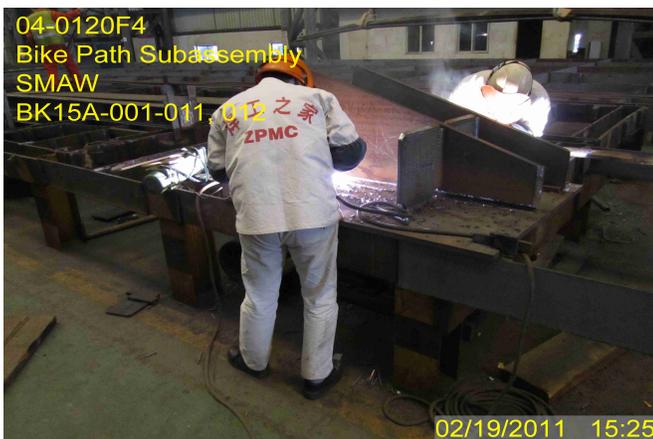
Bike Path Subassembly
Weld: BK15A-001-011, 012
WPS-B-P-2212-TC-U4c
Welder-044011, 040581
2G/CJP/SMAW

The following digital picture illustrates the welding of the Bike Path Subassembly.

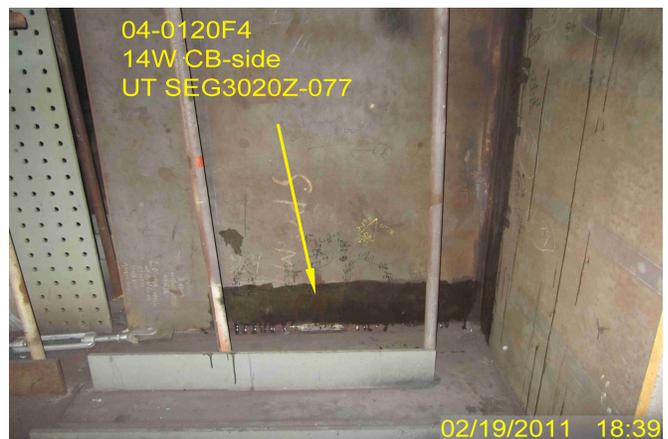
At the time of the verification it was noted that the above component appeared to be within compliance of the contract documents. See Caltrans Ultrasonic Test Report (TL6027), dated 02-19-2011 for additional information.

The following digital picture illustrates weld SEG3020Z-077.
