**DEPARTMENT OF TRANSPORTATION**

Contract #: 04-0120F4Cty: SF/ALA Rte: 80 PM: 13.2/13.9File #: 1.28**WELDING INSPECTION REPORT****Resident Engineer:** Siegenthaler, Peter**Address:** 333 Burma Road**City:** Oakland, CA 94607**Report No:** WIR-020897**Date Inspected:** 18-Feb-2011**Project Name:** SAS Superstructure**OSM Arrival Time:** 630**Prime Contractor:** American Bridge/Fluor Enterprises, a JV**OSM Departure Time:** 1500**Contractor:** American Bridge/Fluor Enterprises, a JV**Location:** Job Site**CWI Name:** See Items Observed**CWI Present:** Yes No**Inspected CWI report:** Yes No N/A**Rod Oven in Use:** Yes No N/A**Electrode to specification:** Yes No N/A**Weld Procedures Followed:** Yes No N/A**Qualified Welders:** Yes No N/A**Verified Joint Fit-up:** Yes No N/A**Approved Drawings:** Yes No N/A**Approved WPS:** Yes No N/A**Delayed / Cancelled:** Yes No N/A**Bridge No:** 34-0006**Component:** Orthotropic Box Girders**Summary of Items Observed:**

## WELDING INSPECTION REPORT

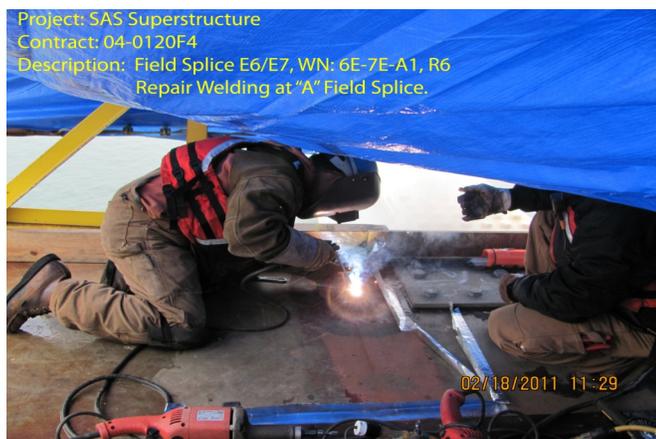
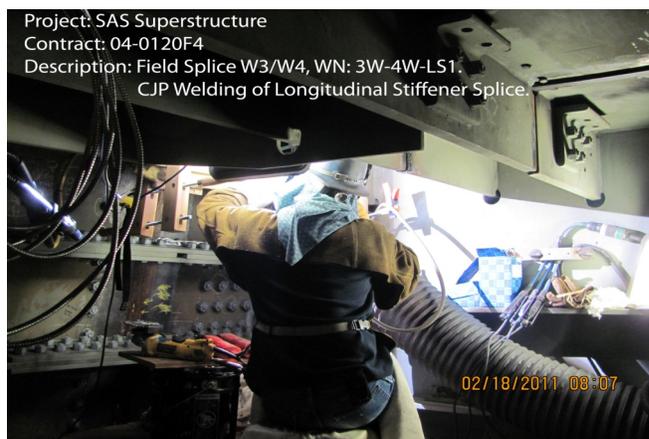
The digital photographs below illustrate some of the work observed during this scheduled shift.
