**DEPARTMENT OF TRANSPORTATION**

Contract #: 04-0120F4Cty: SF/ALA Rte: 80 PM: 13.2/13.9File #: 69.28**WELDING INSPECTION REPORT****Resident Engineer:** Siegenthaler, Peter**Address:** 333 Burma Road**City:** Oakland, CA 94607**Report No:** WIR-020922**Date Inspected:** 23-Feb-2011**Project Name:** SAS Superstructure**OSM Arrival Time:** 700**Prime Contractor:** American Bridge/Fluor Enterprises, a JV**OSM Departure Time:** 1900**Contractor:** Zhenhua Port Machinery Company, Ltd (ZPMC), Changxing Island **Location:** Shanghai, China**CWI Name:** Qiu Wen, An Qing Xiang**CWI Present:** Yes No**Inspected CWI report:** Yes No N/A**Rod Oven in Use:** Yes No N/A**Electrode to specification:** Yes No N/A**Weld Procedures Followed:** Yes No N/A**Qualified Welders:** Yes No N/A**Verified Joint Fit-up:** Yes No N/A**Approved Drawings:** Yes No N/A**Approved WPS:** Yes No N/A**Delayed / Cancelled:** Yes No N/A**Bridge No:** 34-0006**Component:** OBG**Summary of Items Observed:**

## WELDING INSPECTION REPORT

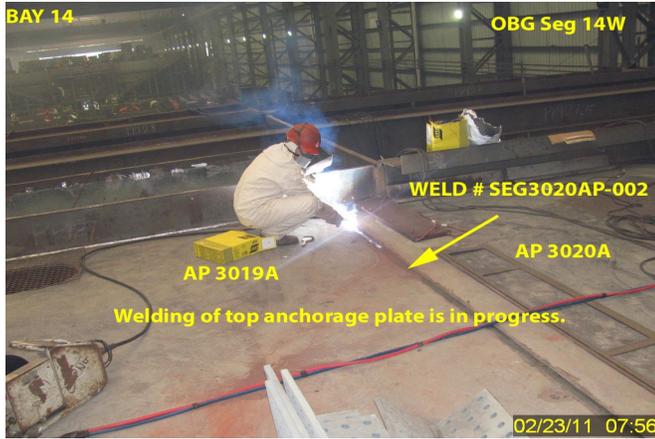
The Flux Cored Arc Welding (FCAW) process on weld joint no: SEG3020AP-002 (Anchorage Plate (AP) 3019A to Anchorage Plate (AP) 3020A, CJP weld in between Panel Point PP125~PP127). The welder is identified as 201215 and was observed welding in the 1G position. ZPMC QC was identified as Mr. Sun Tian Liang. The welding variables recorded by QC appeared to comply with WPS: B-T-2231-ESAB. (Attached photograph provide additional details).
