Contract #: 04-0120F4Cty: SF/ALA Rte: 80 PM: 13.2/13.9File #: 69.28**WELDING INSPECTION REPORT****Resident Engineer:** Siegenthaler, Peter**Address:** 333 Burma Road**City:** Oakland, CA 94607**Report No:** WIR-020930**Date Inspected:** 23-Feb-2011**Project Name:** SAS Superstructure**OSM Arrival Time:** 700**Prime Contractor:** American Bridge/Fluor Enterprises, a JV**OSM Departure Time:** 1900**Contractor:** Zhenhua Port Machinery Company, Ltd (ZPMC), Changxing Island **Location:** Shanghai, China**CWI Name:** Li Yang and Zhu Zhong Hai**CWI Present:** Yes No**Inspected CWI report:** Yes No N/A**Rod Oven in Use:** Yes No N/A**Electrode to specification:** Yes No N/A**Weld Procedures Followed:** Yes No N/A**Qualified Welders:** Yes No N/A**Verified Joint Fit-up:** Yes No N/A**Approved Drawings:** Yes No N/A**Approved WPS:** Yes No N/A**Delayed / Cancelled:** Yes No N/A**Bridge No:** 34-0006**Component:** OBG Trial Assembly**Summary of Items Observed:**

WELDING INSPECTION REPORT

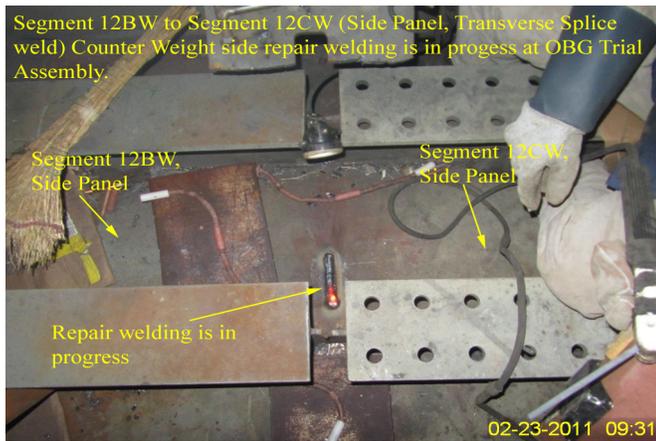
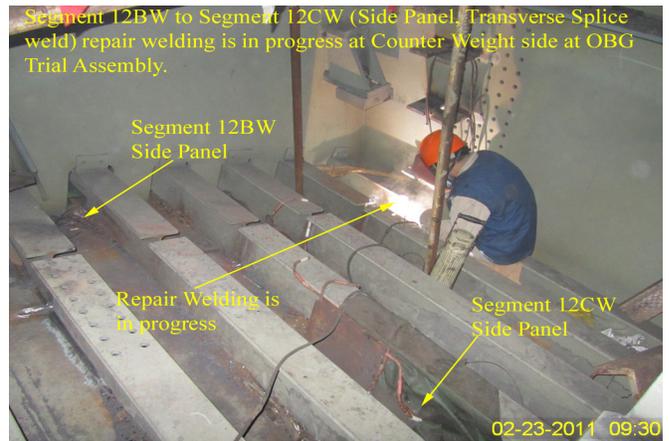
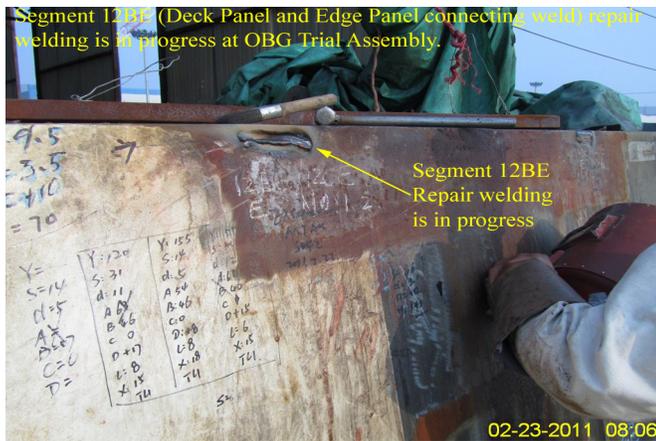
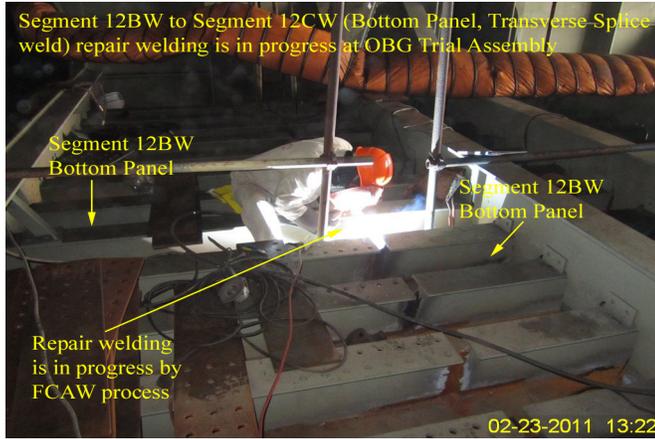
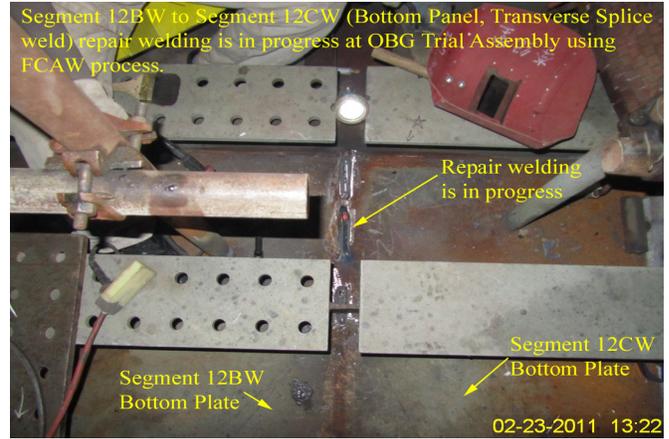
This QA Inspector observed the repair welding by Flux Cored Arc Welding (FCAW) process on a Complete Joint Penetration (CJP) groove weld. The Weld joint was designated as OBW12C-001. The welder identification was 047353 and observed welding in the 1G (Flat) position using approved Welding Procedure Specification WPS-345-FCAW-1G(1F)-ESAB-Repair. The piece mark was identified as the Bottom Panel, at transverse splice. ZPMC performed repair welding in accordance with Welding Repair Report B-WR20263.

This QA Inspector observed the repair welding by Shielded Metal Arc Welding (SMAW) process on a Complete Joint Penetration (CJP) groove weld. The Weld joint was designated as OBW12E-001. The welder identification was 040611 and observed welding in the 3G (Vertical) position using approved Welding Procedure Specification WPS-345-SMAW-3G(3F)-FCM-Repair-1. The piece mark was identified as the Side Panel, at transverse splice. ZPMC performed repair welding in accordance with Welding Repair Report B-WR20193.

This QA Inspector observed the repair welding by Shielded Metal Arc Welding (SMAW) process on a Complete Joint Penetration (CJP) groove weld. The Weld joint was designated as CA3003-005. The welder identification was 044504 and was observed welding in the 4G (Overhead) position using approved Welding Procedure Specification WPS-345-SMAW-3G(3F)-FCM-Repair-1. The piece mark was identified as Deck Panel to Edge Panel hold back weld at work point E2. ZPMC performed repair welding in accordance with Critical Welding Repair Report B-CWR2808.

This QA Inspector observed the repair welding by Shielded Metal Arc Welding (SMAW) process on a Complete Joint Penetration (CJP) groove weld. The Weld joint was designated as Seg3004V-051. The welder identification was 046709 and observed welding in the 2G (Horizontal) position using approved Welding Procedure Specification WPS-345-SMAW-2G(2F)-FCM-Repair-1. The piece mark was identified as the weld connecting the Longitudinal Diaphragm to Bottom Panel hold back. ZPMC performed repair welding in accordance with Welding Repair Report B-WR20150.
