DEPARTMENT OF TRANSPORTATION

Contract #: 04-0120F4Cty: SF/ALA Rte: 80 PM: 13.2/13.9File #: 69.28**WELDING INSPECTION REPORT****Resident Engineer:** Siegenthaler, Peter**Address:** 333 Burma Road**City:** Oakland, CA 94607**Report No:** WIR-020984**Date Inspected:** 20-Feb-2011**Project Name:** SAS Superstructure**OSM Arrival Time:** 1500**Prime Contractor:** American Bridge/Fluor Enterprises, a JV**OSM Departure Time:** 300**Contractor:** Zhenhua Port Machinery Company, Ltd (ZPMC), Changxing Island **Location:** Shanghai, China**CWI Name:** Mr. Lv Li Qing**CWI Present:** Yes No**Inspected CWI report:** Yes No N/A**Rod Oven in Use:** Yes No N/A**Electrode to specification:** Yes No N/A**Weld Procedures Followed:** Yes No N/A**Qualified Welders:** Yes No N/A**Verified Joint Fit-up:** Yes No N/A**Approved Drawings:** Yes No N/A**Approved WPS:** Yes No N/A**Delayed / Cancelled:** Yes No N/A**Bridge No:** 34-0006**Component:** BAY14 OBG**Summary of Items Observed:**

BAY14

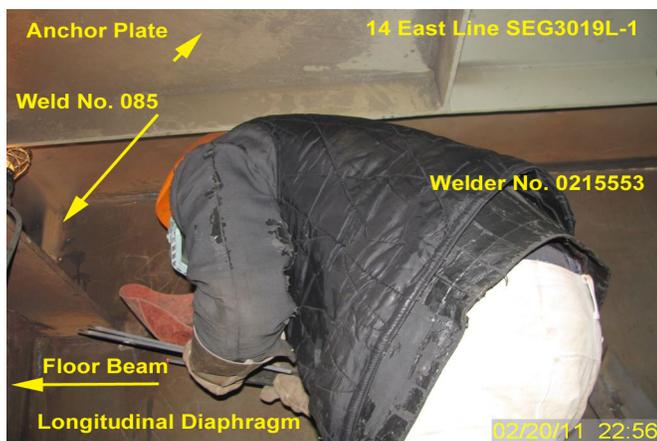
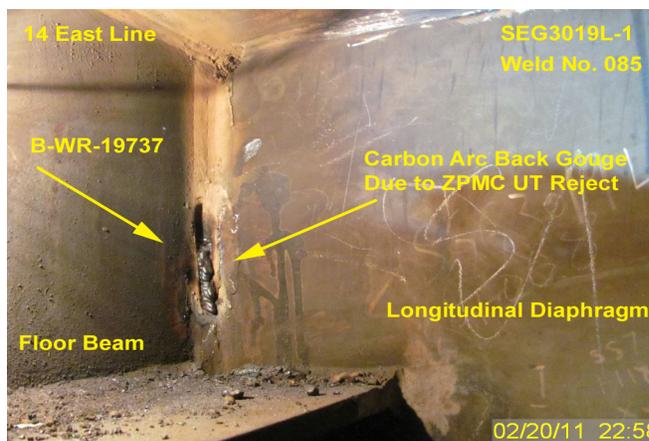
See attached photos
