DEPARTMENT OF TRANSPORTATION

Contract #: 04-0120F4Cty: SF/ALA Rte: 80 PM: 13.2/13.9File #: 69.28**WELDING INSPECTION REPORT****Resident Engineer:** Siegenthaler, Peter**Address:** 333 Burma Road**City:** Oakland, CA 94607**Report No:** WIR-020997**Date Inspected:** 24-Feb-2011**Project Name:** SAS Superstructure**OSM Arrival Time:** 700**Prime Contractor:** American Bridge/Fluor Enterprises, a JV**OSM Departure Time:** 1500**Contractor:** Zhenhua Port Machinery Company, Ltd (ZPMC), Changxing Island **Location:** Shanghai, China**CWI Name:** Qiu Wen, An Qing Xiang**CWI Present:** Yes No**Inspected CWI report:** Yes No N/A**Rod Oven in Use:** Yes No N/A**Electrode to specification:** Yes No N/A**Weld Procedures Followed:** Yes No N/A**Qualified Welders:** Yes No N/A**Verified Joint Fit-up:** Yes No N/A**Approved Drawings:** Yes No N/A**Approved WPS:** Yes No N/A**Delayed / Cancelled:** Yes No N/A**Bridge No:** 34-0006**Component:** OBG**Summary of Items Observed:**

WELDING INSPECTION REPORT

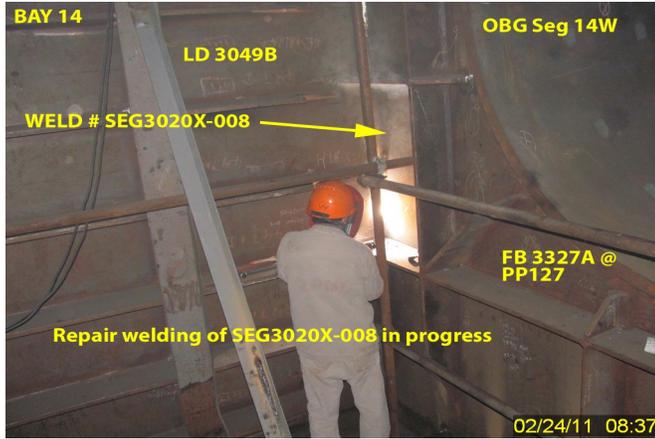
Repair welding of weld joint no: SEG3020X-008 [Floor Beam (FB) 3327A to Longitudinal Diaphragm (LD) 3049B, Complete Joint Penetration (CJP) weld at panel point (PP) 127]. The welder is identified as 047864 and was observed welding in the 3G position. Welding process was identified as Shielded Metal Arc Welding (SMAW). AB/F QA was identified as Mr. Xiao Jun Peng. The welding variables recorded by this QA appeared to comply with WPS: 345-SMAW-3G(3F)-FCM-Repair-1. Repair welding was done as per Critical Welding Repair (CWR) Report: B-CWR 2792 Rev-2. (Attached photograph provide additional details).
