DEPARTMENT OF TRANSPORTATION

Contract #: 04-0120F4Cty: SF/ALA Rte: 80 PM: 13.2/13.9File #: 1.28**WELDING INSPECTION REPORT****Resident Engineer:** Siegenthaler, Peter**Address:** 333 Burma Road**City:** Oakland, CA 94607**Report No:** WIR-021019**Date Inspected:** 22-Feb-2011**Project Name:** SAS Superstructure**OSM Arrival Time:** 630**Prime Contractor:** American Bridge/Fluor Enterprises, a JV**OSM Departure Time:** 1500**Contractor:** American Bridge/Fluor Enterprises, a JV**Location:** Job Site**CWI Name:** See Items Observed**CWI Present:** Yes No**Inspected CWI report:** Yes No N/A**Rod Oven in Use:** Yes No N/A**Electrode to specification:** Yes No N/A**Weld Procedures Followed:** Yes No N/A**Qualified Welders:** Yes No N/A**Verified Joint Fit-up:** Yes No N/A**Approved Drawings:** Yes No N/A**Approved WPS:** Yes No N/A**Delayed / Cancelled:** Yes No N/A**Bridge No:** 34-0006**Component:** Orthotropic Box Girders**Summary of Items Observed:**

WELDING INSPECTION REPORT

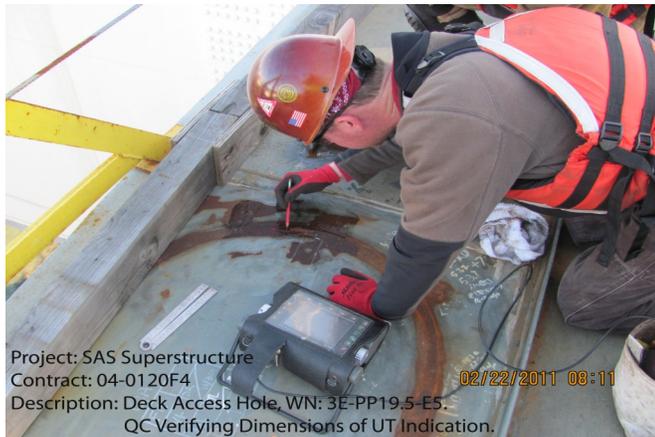
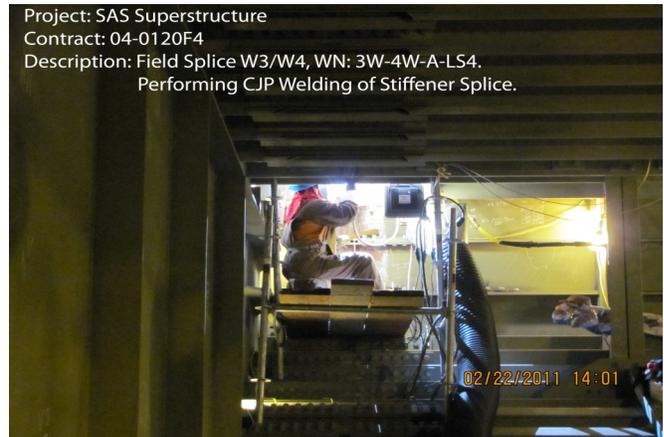
The digital photographs below illustrate some of the work observed during this scheduled shift.
