DEPARTMENT OF TRANSPORTATION

Contract #: 04-0120F4Cty: SF/ALA Rte: 80 PM: 13.2/13.9File #: 1.28**WELDING INSPECTION REPORT****Resident Engineer:** Siegenthaler, Peter**Address:** 333 Burma Road**City:** Oakland, CA 94607**Report No:** WIR-021023**Date Inspected:** 24-Feb-2011**Project Name:** SAS Superstructure**OSM Arrival Time:** 630**Prime Contractor:** American Bridge/Fluor Enterprises, a JV**OSM Departure Time:** 1500**Contractor:** American Bridge/Fluor Enterprises, a JV**Location:** Job Site

Bridge No: 34-0006**Component:** Orthotropic Box Girders**Summary of Items Observed:**

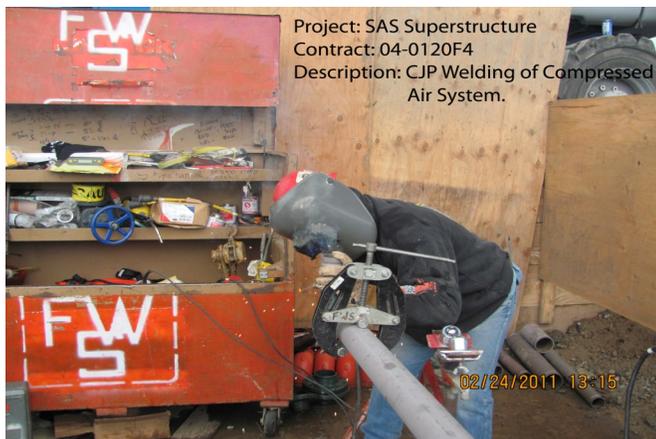
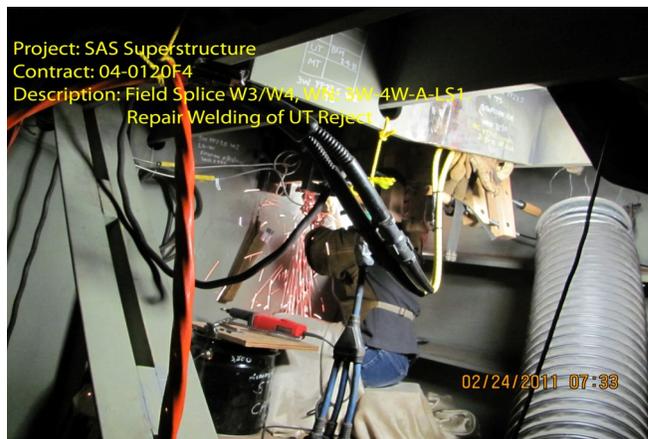
The digital photographs on page 4 of this report illustrate some of the work observed during this scheduled shift.
