**DEPARTMENT OF TRANSPORTATION**

Contract #: 04-0120F4Cty: SF/ALA Rte: 80 PM: 13.2/13.9File #: 99.28**WELDING INSPECTION REPORT****Resident Engineer:** Siegenthaler, Peter**Address:** 333 Burma Road**City:** Oakland, CA 94607**Report No:** WIR-021036**Date Inspected:** 22-Feb-2011**Project Name:** SAS Superstructure**OSM Arrival Time:** 700**Prime Contractor:** American Bridge/Fluor Enterprises, a JV**OSM Departure Time:** 1900**Contractor:** Zhenhua Port Machinery Company, Ltd (ZPMC) Chanxing Island**Location:** Shanghai, China**CWI Name:** Mr. Qui Wen**CWI Present:** Yes No**Inspected CWI report:** Yes No N/A**Rod Oven in Use:** Yes No N/A**Electrode to specification:** Yes No N/A**Weld Procedures Followed:** Yes No N/A**Qualified Welders:** Yes No N/A**Verified Joint Fit-up:** Yes No N/A**Approved Drawings:** Yes No N/A**Approved WPS:** Yes No N/A**Delayed / Cancelled:** Yes No N/A**Bridge No:** 34-0006**Component:** OBG Segment**Summary of Items Observed:**

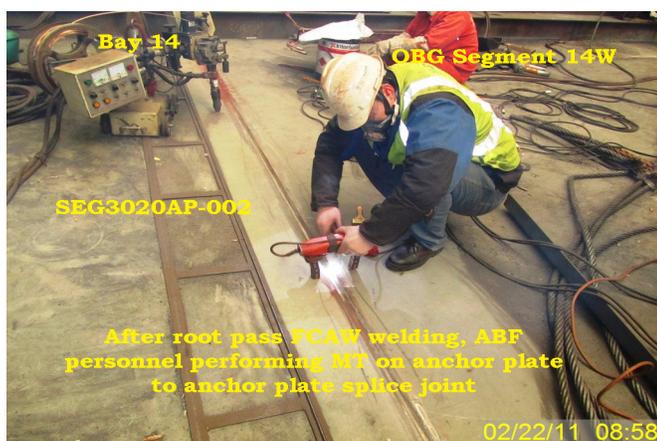
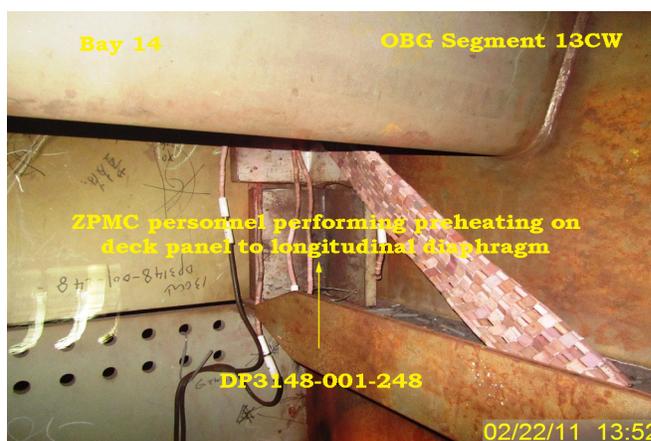
This QA inspector observed ABF personnel performed Magnetic Particle Testing on OBG Segment 14W located on Anchor plate to Anchor plate splice joint weld after the root and hot pas weld. The weld number is identified as SEG3020AP-002. See the attached pictures.
