Contract #: 04-0120F4Cty: SF/ALA Rte: 80 PM: 13.2/13.9File #: 1.28**WELDING INSPECTION REPORT****Resident Engineer:** Siegenthaler, Peter**Address:** 333 Burma Road**City:** Oakland, CA 94607**Report No:** WIR-021078**Date Inspected:** 26-Feb-2011**Project Name:** SAS Superstructure**OSM Arrival Time:** 700**Prime Contractor:** American Bridge/Fluor Enterprises, a JV**OSM Departure Time:** 1530**Contractor:** American Bridge/Fluor Enterprises, a JV**Location:** Job Site**CWI Name:** See below**CWI Present:** Yes No**Inspected CWI report:** Yes No N/A**Rod Oven in Use:** Yes No N/A**Electrode to specification:** Yes No N/A**Weld Procedures Followed:** Yes No N/A**Qualified Welders:** Yes No N/A**Verified Joint Fit-up:** Yes No N/A**Approved Drawings:** Yes No N/A**Approved WPS:** Yes No N/A**Delayed / Cancelled:** Yes No N/A**Bridge No:** 34-0006**Component:** SAS OBG**Summary of Items Observed:**

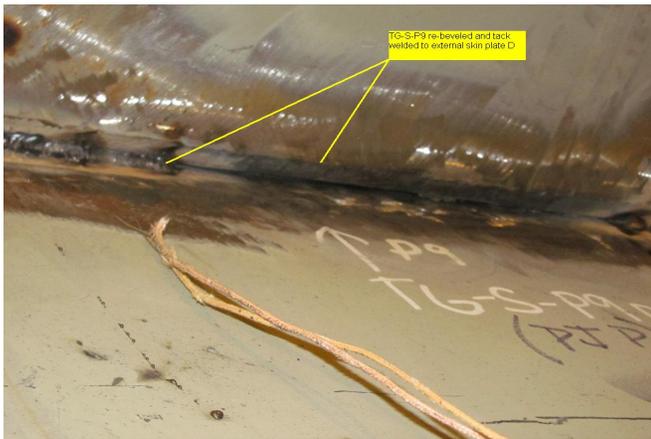
After all of the cover plates were installed in all 4 shafts the QA Inspector randomly observed the ABF welder Rick Clayborn re-bevel cover plate identified as TG-S-P9. The QA Inspector noted it was previously determined that the bevel angle for the partial joint penetration groove weld did not meet the allowable tolerances of AWS D1.5-02. The QA Inspector randomly observed the ABF welder re-bevel one side of the plate against the outer the skin plate of the South shaft utilizing a carbon arc. After the carbon arcing was completed the QA Inspector randomly observed the ABF apprentice reshape and restore the bevel utilizing a grinding disc and a burr bit grinder. After the grinding was completed the QC Inspector performed visual testing and verified the bevel angle of 45° did meet the specified tolerances of AWS D1.5-02 (pictured below). The QA Inspector observed the ABF welder Rick Clayborn re-tack the above identified plate with 1/8" E9018 low hydrogen electrodes. The QA Inspector noted at the end of the shift all cover plates had been fit up and tack welded into place.
