DEPARTMENT OF TRANSPORTATION

Contract #: 04-0120F4Cty: SF/ALA Rte: 80 PM: 13.2/13.9File #: 69.28**WELDING INSPECTION REPORT****Resident Engineer:** Siegenthaler, Peter**Address:** 333 Burma Road**City:** Oakland, CA 94607**Report No:** WIR-021110**Date Inspected:** 26-Feb-2011**Project Name:** SAS Superstructure**OSM Arrival Time:** 700**Prime Contractor:** American Bridge/Fluor Enterprises, a JV**OSM Departure Time:** 1900**Contractor:** Zhenhua Port Machinery Company, Ltd (ZPMC), Changxing Island **Location:** Shanghai, China**CWI Name:** Li Yang and Zhu Zhong Hai**CWI Present:** Yes No**Inspected CWI report:** Yes No N/A**Rod Oven in Use:** Yes No N/A**Electrode to specification:** Yes No N/A**Weld Procedures Followed:** Yes No N/A**Qualified Welders:** Yes No N/A**Verified Joint Fit-up:** Yes No N/A**Approved Drawings:** Yes No N/A**Approved WPS:** Yes No N/A**Delayed / Cancelled:** Yes No N/A**Bridge No:** 34-0006**Component:** OBG Trial Assembly**Summary of Items Observed:**

Orthotropic Box Girder (OBG) at Trial Assembly Areas

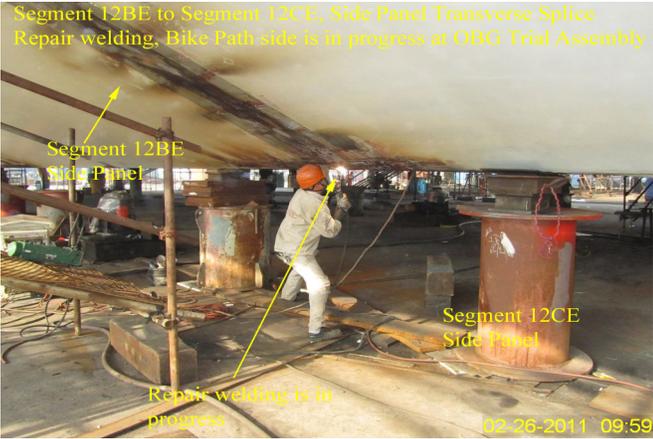
Segment 12BE to Segment 12CE (Side Panel, Transverse Splice weld)

This QA Inspector observed the repair welding by Shielded Metal Arc Welding (SMAW) process on a Complete Joint Penetration (CJP) groove weld. The Weld joint was designated as OBW12E-002. The welder identification was 067752 and observed welding in the 4G (Overhead) position using approved Welding Procedure Specification WPS-345-SMAW-4G(4F)-FCM-Repair-1. The piece mark was identified as the Side Panel, Cross Beam side at transverse splice. ZPMC performed repair welding in accordance with Critical Welding Repair Report B-CWR2805.
