DEPARTMENT OF TRANSPORTATION

Contract #: 04-0120F4Cty: SF/ALA Rte: 80 PM: 13.2/13.9File #: 69.28**WELDING INSPECTION REPORT****Resident Engineer:** Siegenthaler, Peter**Address:** 333 Burma Road**City:** Oakland, CA 94607**Report No:** WIR-021111**Date Inspected:** 25-Feb-2011**Project Name:** SAS Superstructure**OSM Arrival Time:** 700**Prime Contractor:** American Bridge/Fluor Enterprises, a JV**OSM Departure Time:** 1900**Contractor:** Zhenhua Port Machinery Company, Ltd (ZPMC), Changxing Island **Location:** Shanghai, China**CWI Name:** Li Yang and Zhu Zhong Hai**CWI Present:** Yes No**Inspected CWI report:** Yes No N/A**Rod Oven in Use:** Yes No N/A**Electrode to specification:** Yes No N/A**Weld Procedures Followed:** Yes No N/A**Qualified Welders:** Yes No N/A**Verified Joint Fit-up:** Yes No N/A**Approved Drawings:** Yes No N/A**Approved WPS:** Yes No N/A**Delayed / Cancelled:** Yes No N/A**Bridge No:** 34-0006**Component:** OBG Trial Assembly**Summary of Items Observed:**

Orthotropic Box Girder (OBG) at Trial Assembly Areas

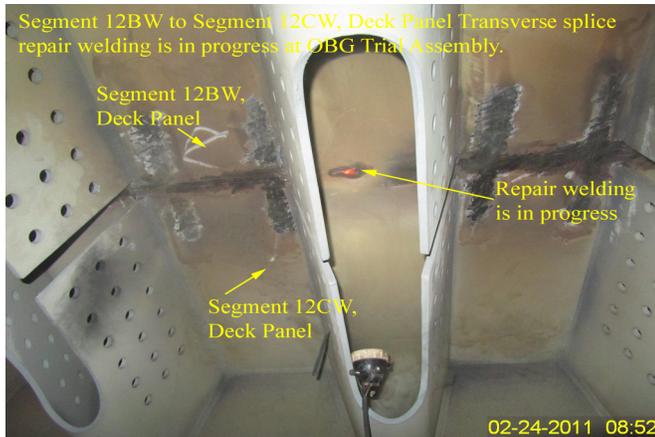
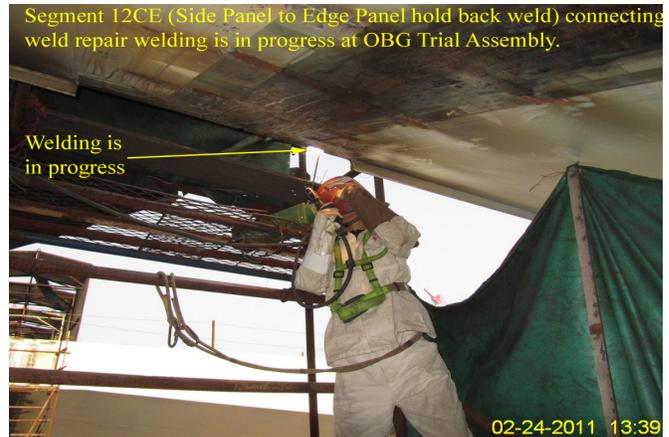
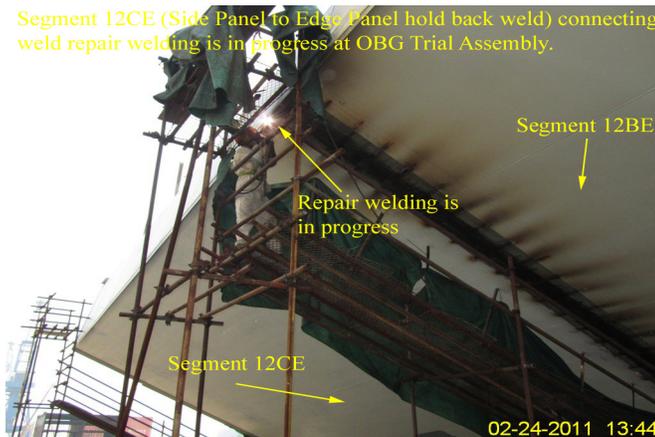
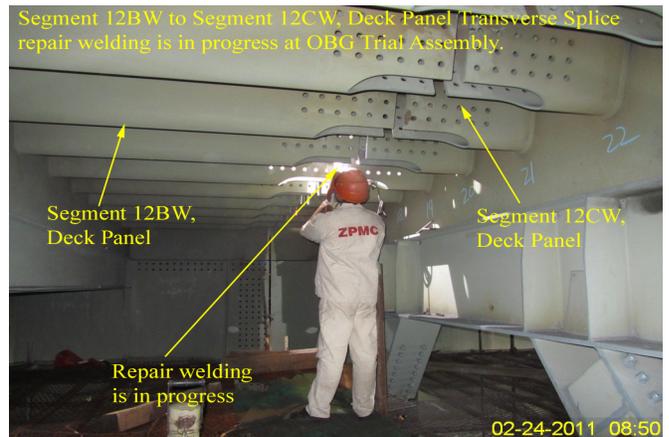
Please reference the pictures attached for more comprehensive details.
