**DEPARTMENT OF TRANSPORTATION**

Contract #: 04-0120F4Cty: SF/ALA Rte: 80 PM: 13.2/13.9File #: 69.28**WELDING INSPECTION REPORT****Resident Engineer:** Siegenthaler, Peter**Address:** 333 Burma Road**City:** Oakland, CA 94607**Report No:** WIR-021231**Date Inspected:** 12-Feb-2011**Project Name:** SAS Superstructure**OSM Arrival Time:** 700**Prime Contractor:** American Bridge/Fluor Enterprises, a JV**OSM Departure Time:** 1900**Contractor:** Zhenhua Port Machinery Company, Ltd (ZPMC), Changxing Island **Location:** Shanghai, China**CWI Name:** Geng Wei**CWI Present:** Yes No**Inspected CWI report:** Yes No N/A**Rod Oven in Use:** Yes No N/A**Electrode to specification:** Yes No N/A**Weld Procedures Followed:** Yes No N/A**Qualified Welders:** Yes No N/A**Verified Joint Fit-up:** Yes No N/A**Approved Drawings:** Yes No N/A**Approved WPS:** Yes No N/A**Delayed / Cancelled:** Yes No N/A**Bridge No:** 34-0006**Component:** OBG Components**Summary of Items Observed:**

## WELDING INSPECTION REPORT

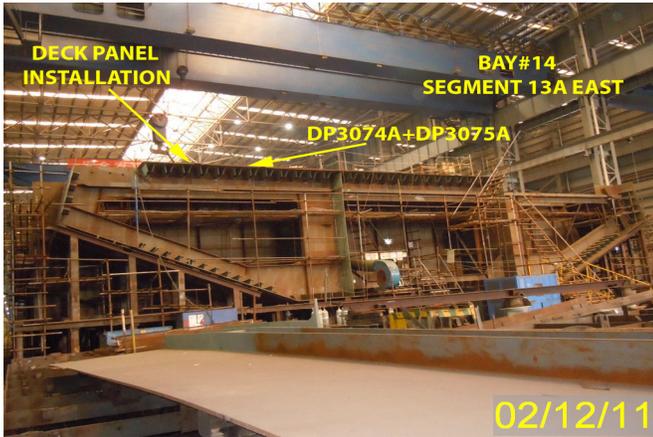
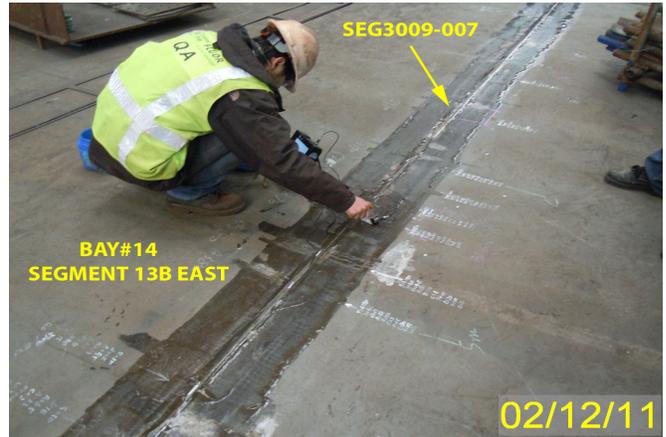
This QA inspector observed deck panel installation and fit-up on floor beam (FL3) side of 13A east segment. The member is identified as OBG Component. (See attached photo)
