DEPARTMENT OF TRANSPORTATION

Contract #: 04-0120F4Cty: SF/ALA Rte: 80 PM: 13.2/13.9File #: 69.28**WELDING INSPECTION REPORT****Resident Engineer:** Siegenthaler, Peter**Address:** 333 Burma Road**City:** Oakland, CA 94607**Report No:** WIR-021266**Date Inspected:** 27-Jun-2010**Project Name:** SAS Superstructure**OSM Arrival Time:** 700**Prime Contractor:** American Bridge/Fluor Enterprises, a JV**OSM Departure Time:** 1900**Contractor:** Zhenhua Port Machinery Company, Ltd (ZPMC), Changxing Island **Location:** Shanghai, China

Bridge No: 34-0006**Component:** OBG Segment Assembly**Summary of Items Observed:**

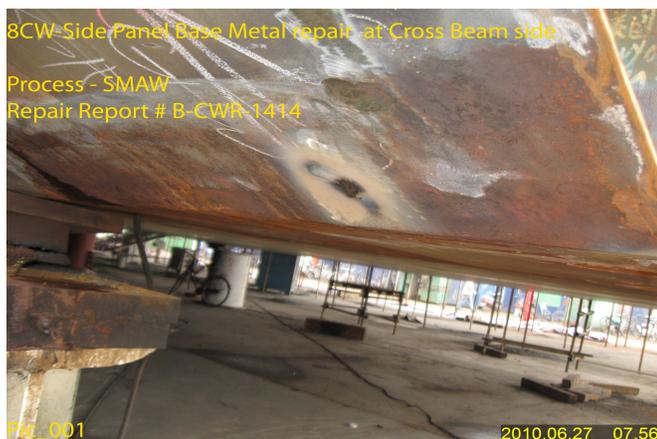
OBG Segment 9BE-9CE

Shielded Metal Arc Welding (SMAW) in the 4F position of 8CW Side Panel base metal at Cross beam side connecting end of 9AW, as per repair report # B-CWR-1414. The welder is identified as 045246. ZPMC Quality Control (QC) is identified as Xu Jin Long. The welding variables recorded by QC appeared to comply with WPS-345-SMAW 4G(4F)-FCM-Repair. See attached photograph Pic_001

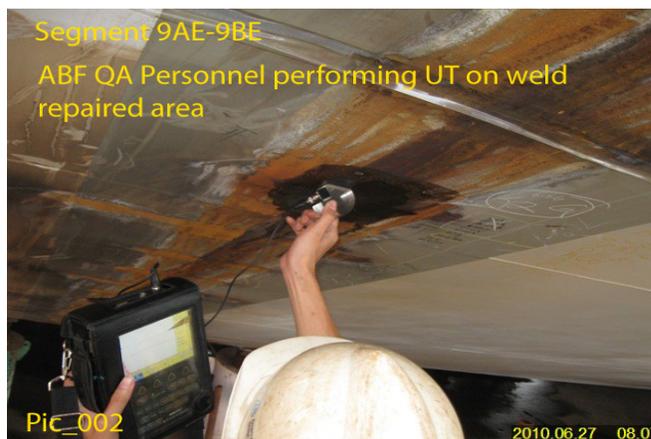
OBG Segment 9AE-9BE

During in process visual inspection of 9AE-9BE. This QA Inspector observed ABF Quality Assurance (QA) personnel performing Ultrasonic Testing (UT) on weld repaired area of 9AE-9BE Side Panel at Bike Path side. See attached photograph Pic_002
