DEPARTMENT OF TRANSPORTATION

Quality Assurance and Source Inspection

Contract #: 04-0120F4Cty: SF/ALA Rte: 80 PM: 13.2/13.9File #: 1.28**WELDING INSPECTION REPORT****Resident Engineer:** Siegenthaler, Peter**Address:** 333 Burma Road**City:** Oakland, CA 94607**Report No:** WIR-021328**Date Inspected:** 01-Mar-2011**Project Name:** SAS Superstructure**OSM Arrival Time:** 700**Prime Contractor:** American Bridge/Fluor Enterprises, a JV**OSM Departure Time:** 1730**Contractor:** American Bridge/Fluor Enterprises, a JV**Location:** Job Site**CWI Name:** See Items Observed**CWI Present:** Yes No**Inspected CWI report:** Yes No N/A**Rod Oven in Use:** Yes No N/A**Electrode to specification:** Yes No N/A**Weld Procedures Followed:** Yes No N/A**Qualified Welders:** Yes No N/A**Verified Joint Fit-up:** Yes No N/A**Approved Drawings:** Yes No N/A**Approved WPS:** Yes No N/A**Delayed / Cancelled:** Yes No N/A**Bridge No:** 34-0006**Component:** Orthotropic Box Girders**Summary of Items Observed:**

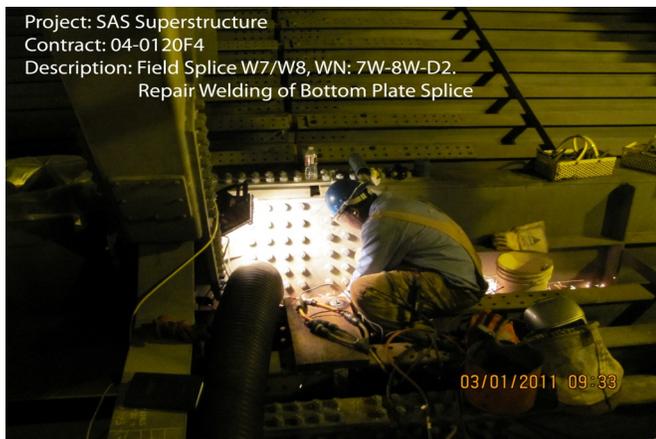
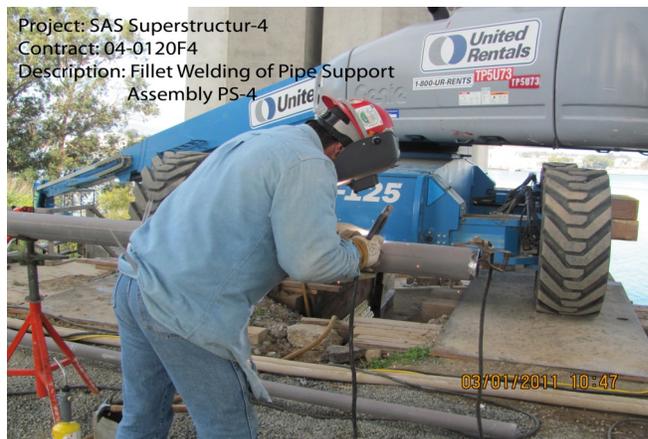
The digital photographs on page 4 of this report illustrate some of the work observed during this scheduled shift.
