DEPARTMENT OF TRANSPORTATION

Quality Assurance and Source Inspection

Contract #: 04-0120F4Cty: SF/ALA Rte: 80 PM: 13.2/13.9File #: 1.28**WELDING INSPECTION REPORT****Resident Engineer:** Siegenthaler, Peter**Address:** 333 Burma Road**City:** Oakland, CA 94607**Report No:** WIR-021330**Date Inspected:** 01-Mar-2011**Project Name:** SAS Superstructure**OSM Arrival Time:** 700**Prime Contractor:** American Bridge/Fluor Enterprises, a JV**OSM Departure Time:** 1730**Contractor:** American Bridge/Fluor Enterprises, a JV**Location:** Job Site

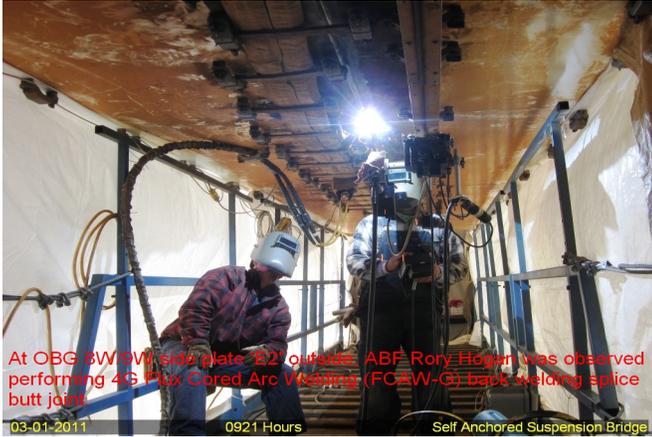
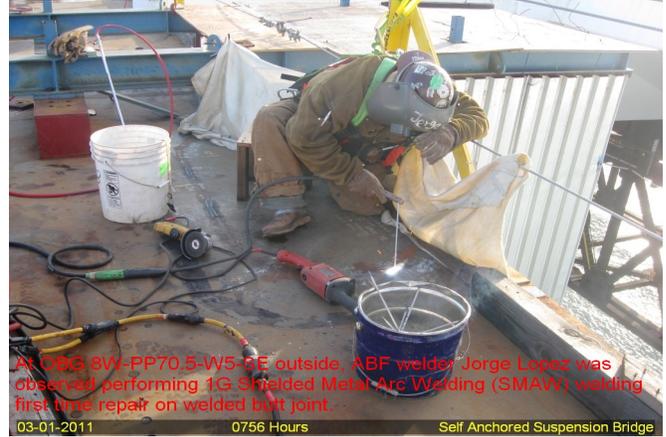
QA randomly observed ABF/JV qualified welder Rory Hogan continuing to perform CJP groove (splice) back welding fill pass on Orthotropic Box Girder (OBG) 8W/9W side plate 'E2' outside. The welder was observed back welding in the 4G (overhead) position utilizing a dual shield Flux Cored Arc Welding (FCAW-G) with E71T-1M, 1/16" diameter wire electrode and implementing Caltrans approved Welding Procedure Specification (WPS) ABF-WPS-D15-3110-4. The welder was using a track mounted welder holder assembly that was remotely controlled. The joint being welded has the backing bar gouged using the Esab Plasma Arc machine and was ground smooth. The gouged and ground splice butt joint was also Non Destructive Testing (NDT) tested using the Magnetic Particle Testing (MT). The splice joint was preheated and maintained to greater than 150 degrees Fahrenheit using Miller Proheat 35 Induction Heating System located on top of the plate prior welding and by moving the blanket to the side of the weld being welded during welding. The vicinity was also properly protected from wind and other climatic conditions. ABF Quality Control (QC) Steve Jensen was noted monitoring the welding parameters of the welder. At the end of the shift, fill pass welding was still continuing and should remain tomorrow.

At OBG 8W-PP70.5-W5-SE deck access hole to top deck plate outside/inside, QA randomly observed ABF/JV qualified welder Jorge Lopez perform CJP repair welding. The welder was noted welding in 1G (flat) position utilizing SMAW with 1/8" diameter E7018H4R electrode implementing Caltrans approved Welding Procedure

Specification (WPS) ABF-WPS-D15-1001 Repair. The first time welding repairs were excavated to a boat shape profile and were tested with Magnetic Particle Testing (MT) prior welding. During welding, ABF QC John Pagliero was noted monitoring the welder and his welding parameters. QA noted parameter during welding was 135 amperes which appears in compliance to the WPS. At the end of the shift, welding repair at the following locations was completed. The locations of the repairs were noted below;
