**DEPARTMENT OF TRANSPORTATION**

Contract #: 04-0120F4Cty: SF/ALA Rte: 80 PM: 13.2/13.9File #: 69.28**WELDING INSPECTION REPORT****Resident Engineer:** Siegenthaler, Peter**Address:** 333 Burma Road**City:** Oakland, CA 94607**Report No:** WIR-021343**Date Inspected:** 25-Feb-2011**Project Name:** SAS Superstructure**OSM Arrival Time:** 700**Prime Contractor:** American Bridge/Fluor Enterprises, a JV**OSM Departure Time:** 1900**Contractor:** Zhenhua Port Machinery Company, Ltd (ZPMC), Changxing Island **Location:** Shanghai, China**CWI Name:** Geng Wei**CWI Present:** Yes No**Inspected CWI report:** Yes No N/A**Rod Oven in Use:** Yes No N/A**Electrode to specification:** Yes No N/A**Weld Procedures Followed:** Yes No N/A**Qualified Welders:** Yes No N/A**Verified Joint Fit-up:** Yes No N/A**Approved Drawings:** Yes No N/A**Approved WPS:** Yes No N/A**Delayed / Cancelled:** Yes No N/A**Bridge No:** 34-0006**Component:** OBG Components**Summary of Items Observed:**

## EAST GRILLAGE INSTALLATION ON BIKE PATH SIDE OF 13A EAST SEGMENT

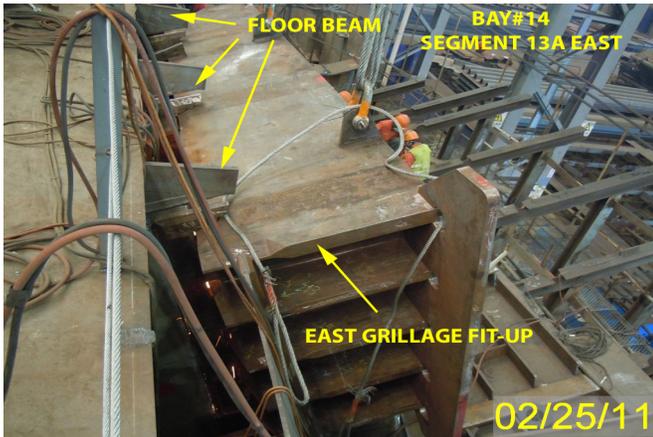
This QA inspector observed east side grillage installation and fit-up on bike path side of 13A east segment. The member is identified as OBG Component. (See attached photo)

Unless otherwise noted, all work observed on this date appeared to generally comply with applicable contract documents.
