DEPARTMENT OF TRANSPORTATION

Quality Assurance and Source Inspection

WELDING INSPECTION REPORT

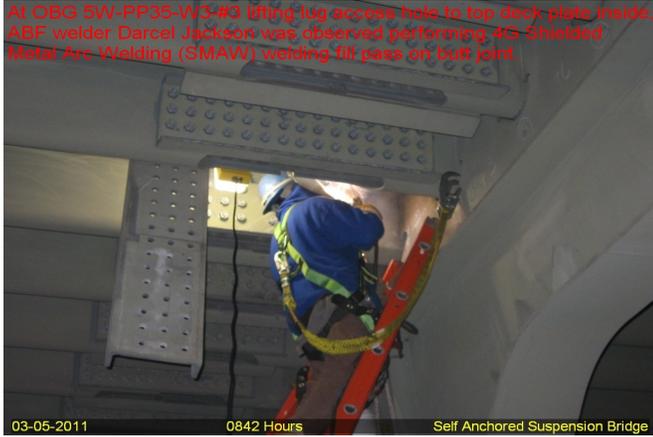
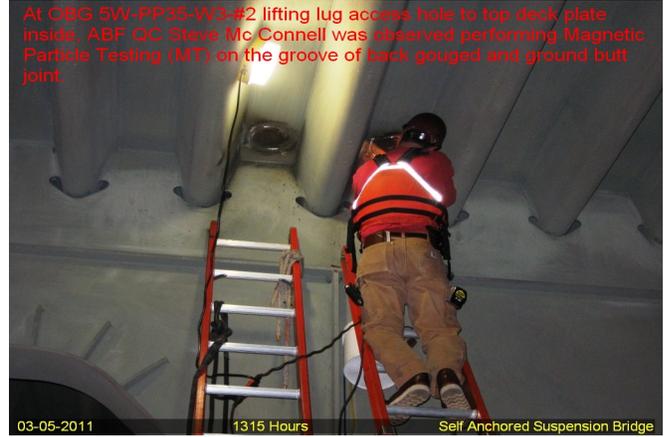
At OBG 5W-PP35-W3-#1 & 3 lifting lug access hole to top deck plate inside - ABF welder Darcel Jackson was observed perform 4G SMAW back welding fill pass to cover pass on the infill plate to top deck plate butt joint. The welder was noted using 1/8" diameter E7018H4R electrode implementing Caltrans approved Welding Procedure Specification (WPS) ABF-WPS-D15-1110A. During welding, ABF QC Steve Mc Connell was noted monitoring the welder's welding parameters. During the shift, cover pass welding on this location was completed and the welder flush ground the cover reinforcement of the weld joint. After the completion of the grinding, the welder called QC for the inspection of the weld cover flush grinding. QA noted QC performed the inspection and accepted them. QA performed the visual test (VT) verification of the flush ground cover of the weld joint. During the verification, the flush grinding of the weld cover was noted smooth and the grinding cut of the flush grinding was parallel to the direction of the bridge as required.

After the acceptance of the two lifting lug holes, the welder has moved to lifting lug holes number 2 and 4 of the same location. In here, the welder performed back gouging using carbon air arc and smooth grinding of the groove after gouging. QA noted ABF QC perform Magnetic Particle Testing (MT) on the groove surface of the back gouged and ground butt joints. QC found no indications during the test and the welder resumed welding. The welder has completed back welding fill pass to cover pass of the lifting lug holes # 2 & 4 and was flush grinding the weld cover reinforcement when the shift has ended.
