**DEPARTMENT OF TRANSPORTATION**

Contract #: 04-0120F4Cty: SF/ALA Rte: 80 PM: 13.2/13.9File #: 1.28**WELDING INSPECTION REPORT****Resident Engineer:** Siegenthaler, Peter**Address:** 333 Burma Road**City:** Oakland, CA 94607**Report No:** WIR-021512**Date Inspected:** 05-Mar-2011**Project Name:** SAS Superstructure**OSM Arrival Time:** 700**Prime Contractor:** American Bridge/Fluor Enterprises, a JV**OSM Departure Time:** 1530**Contractor:** American Bridge/Fluor Enterprises, a JV**Location:** Job Site**CWI Name:** See below**CWI Present:** Yes No**Inspected CWI report:** Yes No N/A**Rod Oven in Use:** Yes No N/A**Electrode to specification:** Yes No N/A**Weld Procedures Followed:** Yes No N/A**Qualified Welders:** Yes No N/A**Verified Joint Fit-up:** Yes No N/A**Approved Drawings:** Yes No N/A**Approved WPS:** Yes No N/A**Delayed / Cancelled:** Yes No N/A**Bridge No:** 34-0006**Component:** SAS OBG**Summary of Items Observed:**

## WELDING INSPECTION REPORT

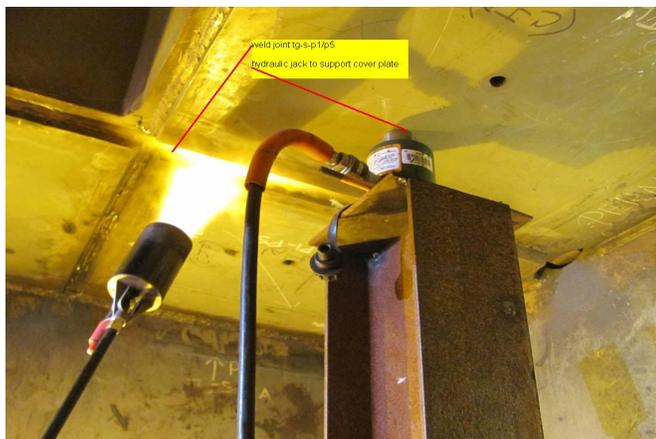
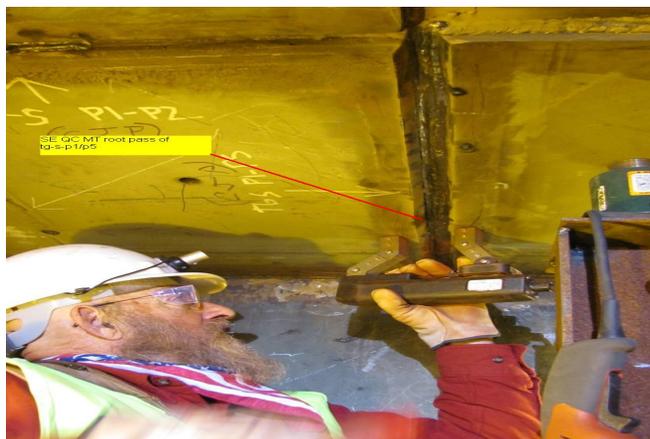
The QA Inspector randomly observed the ABF welder identified as Richard Garcia (#5892) excavating cracked weld material from the weld joint identified as TG-S-P1/P5. The QA Inspector noted the weld joints identified as P1/P5 and P1/P2 were previously determined to be cracked full length and required removed and repair. The QA Inspector noted the repair procedure was previously submitted and approved for excavation and welding. The QA Inspector randomly observed the repair was being performed in accordance with RWR 201103-001. The QA Inspector observed the ABF welder utilized carbon arc gouging and grinding to completely remove the weld material from the weld joint. Prior to removing all of the weld material, the QA Inspector observed the welder utilized a hydraulic jack to hold the cover plate in place and attempt to reduce the amount of distortion to plate due to the heat and lack of weld material on the P1/P5 weld joint. Once the hydraulic jack was in place and all of the weld material was removed, the QA Inspector observed the SE QC Inspector perform visual and magnetic particle testing of 100% of the P1/P5 weld joint. The QC Inspector informed the QA Inspector no relevant indications were located at the time of the testing. The QA Inspector performed random visual testing of the excavated weld joint and noted the weld joint appeared to be in compliance with contract requirements and ready for weld repair. The QA Inspector randomly observed the ABF welder preheat the area to approximately 250°F and begin the SMAW root pass joining the P5/P1 plates to the stiffener. The Inspector noted the weld was utilizing 1/8" E9018 low hydrogen electrodes with 131 Amps. The QA Inspector randomly observed the ABF welder deposit several passes for the multi pass root. After the root pass was completed the QA Inspector randomly observed the QC Inspector perform MT of the completed root pass. The QA Inspector noted no relevant indications were located at the time of the testing. The QA Inspector noted the ABF welder spent the remainder of the shift performing the SMAW fill passes.

In addition the QA Inspector randomly observed the ABF welder identified as Jason Collins performing SMAW fill/cover passes at weld joint identified as TG-S-P4/P6. The QA Inspector randomly observed the ABF welder completing a weld that was started on the previous day shift. The QA Inspector noted the ABF welder was utilizing 5/32" E9018 electrodes with 172 Amps in the 4G position. The QA Inspector noted the weld was completed at the end of the shift and the QC Inspector Fred Vonhoff performed VT and marked up several areas to have additional weld material deposited.
