DEPARTMENT OF TRANSPORTATION

Contract #: 04-0120F4Cty: SF/ALA Rte: 80 PM: 13.2/13.9File #: 69.28**WELDING INSPECTION REPORT****Resident Engineer:** Siegenthaler, Peter**Address:** 333 Burma Road**City:** Oakland, CA 94607**Report No:** WIR-021616**Date Inspected:** 07-Mar-2011**Project Name:** SAS Superstructure**OSM Arrival Time:** 700**Prime Contractor:** American Bridge/Fluor Enterprises, a JV**OSM Departure Time:** 1900**Contractor:** Zhenhua Port Machinery Company, Ltd (ZPMC), Changxing Island **Location:** Shanghai, China**CWI Name:** Geng Wei**CWI Present:** Yes No**Inspected CWI report:** Yes No N/A**Rod Oven in Use:** Yes No N/A**Electrode to specification:** Yes No N/A**Weld Procedures Followed:** Yes No N/A**Qualified Welders:** Yes No N/A**Verified Joint Fit-up:** Yes No N/A**Approved Drawings:** Yes No N/A**Approved WPS:** Yes No N/A**Delayed / Cancelled:** Yes No N/A**Bridge No:** 34-0006**Component:** OBG Components**Summary of Items Observed:**

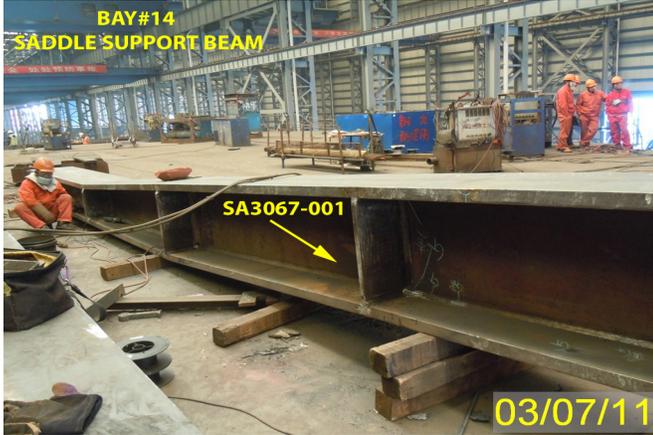
Visual Inspection Testing (VT) on Saddle Support Beam

This QA inspector performed random VT of the area previously tested and accepted by ZPMC Quality Control personnel. The member is identified as OBG Component. The identified component designations reviewed are as follows:

SEG3067-001-019~022; 024~027

(See attached photo)
