**DEPARTMENT OF TRANSPORTATION**

Contract #: 04-0120F4Cty: SF/ALA Rte: 80 PM: 13.2/13.9File #: 99.28**WELDING INSPECTION REPORT****Resident Engineer:** Siegenthaler, Peter**Address:** 333 Burma Road**City:** Oakland, CA 94607**Report No:** WIR-021636**Date Inspected:** 14-Nov-2010**Project Name:** SAS Superstructure**OSM Arrival Time:** 700**Prime Contractor:** American Bridge/Fluor Enterprises, a JV**OSM Departure Time:** 1900**Contractor:** Zhenhua Port Machinery Company, Ltd (ZPMC) Chanxing Island**Location:** Shanghai, China**CWI Name:** Mr. AN QIANG XING**CWI Present:** Yes No**Inspected CWI report:** Yes No N/A**Rod Oven in Use:** Yes No N/A**Electrode to specification:** Yes No N/A**Weld Procedures Followed:** Yes No N/A**Qualified Welders:** Yes No N/A**Verified Joint Fit-up:** Yes No N/A**Approved Drawings:** Yes No N/A**Approved WPS:** Yes No N/A**Delayed / Cancelled:** Yes No N/A**Bridge No:** 34-0006**Component:** OBG Segment**Summary of Items Observed:**

## WELDING INSPECTION REPORT

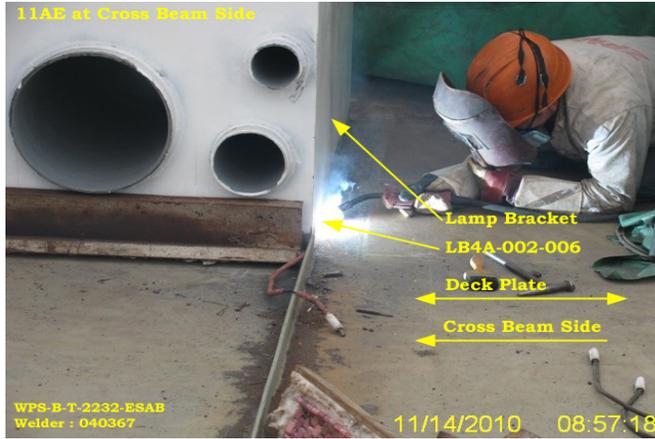
ZPMC welding personnel performing Flux Core Arc Welding (FCAW) of Partial Joint Penetration (PJP) welds joining the deck plate to lamp bracket weld joint located on 11AE at cross beam side. The weld is designated as LB4A-002-006. The welder is identified as 040367. ZPMC QC Mr. ANQING XING was onsite monitoring the welding variables. The inprocess FCAW appears to be progressing in compliance with WPS-B-T-2232-ESAB. See attached picture for detail of the weld.
