DEPARTMENT OF TRANSPORTATION

Contract #: 04-0120F4Cty: SF/ALA Rte: 80 PM: 13.2/13.9File #: 99.28**WELDING INSPECTION REPORT****Resident Engineer:** Siegenthaler, Peter**Address:** 333 Burma Road**City:** Oakland, CA 94607**Report No:** WIR-021746**Date Inspected:** 13-Mar-2011**Project Name:** SAS Superstructure**OSM Arrival Time:** 700**Prime Contractor:** American Bridge/Fluor Enterprises, a JV**OSM Departure Time:** 1900**Contractor:** Zhenhua Port Machinery Company, Ltd (ZPMC) Chanxing Island**Location:** Shanghai, China**CWI Name:** Mr. Sha Zhi**CWI Present:** Yes No**Inspected CWI report:** Yes No N/A**Rod Oven in Use:** Yes No N/A**Electrode to specification:** Yes No N/A**Weld Procedures Followed:** Yes No N/A**Qualified Welders:** Yes No N/A**Verified Joint Fit-up:** Yes No N/A**Approved Drawings:** Yes No N/A**Approved WPS:** Yes No N/A**Delayed / Cancelled:** Yes No N/A**Bridge No:** 34-0006**Component:** OBG Segment**Summary of Items Observed:**

WELDING INSPECTION REPORT

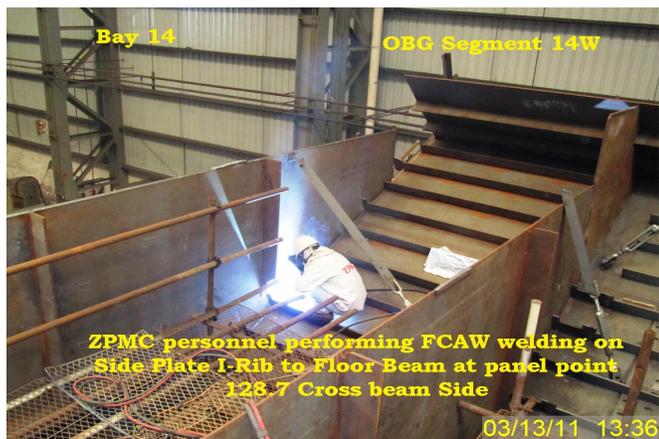
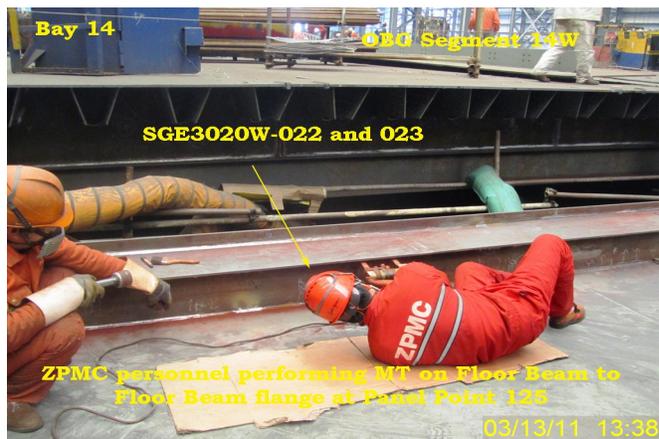
This QA inspector observed ZPMC personnel performed Magnetic Particle Testing (MT) on Floor Beam to Floor Beam Flange at panel point 125 of OBG Segment 14W. The weld number is identified as SEG3020W-022 and 023. See the attached pictures.
