Contract #: 04-0120F4Cty: SF/ALA Rte: 80 PM: 13.2/13.9File #: 69.28**WELDING INSPECTION REPORT****Resident Engineer:** Siegenthaler, Peter**Address:** 333 Burma Road**City:** Oakland, CA 94607**Report No:** WIR-021779**Date Inspected:** 16-Mar-2011**Project Name:** SAS Superstructure**OSM Arrival Time:** 700**Prime Contractor:** American Bridge/Fluor Enterprises, a JV**OSM Departure Time:** 1900**Contractor:** Zhenhua Port Machinery Company, Ltd (ZPMC), Changxing Island **Location:** Shanghai, China**CWI Name:** Li Yang and Zhu Zhong Hai**CWI Present:** Yes No**Inspected CWI report:** Yes No N/A**Rod Oven in Use:** Yes No N/A**Electrode to specification:** Yes No N/A**Weld Procedures Followed:** Yes No N/A**Qualified Welders:** Yes No N/A**Verified Joint Fit-up:** Yes No N/A**Approved Drawings:** Yes No N/A**Approved WPS:** Yes No N/A**Delayed / Cancelled:** Yes No N/A**Bridge No:** 34-0006**Component:** OBG Trial Assembly**Summary of Items Observed:**

WELDING INSPECTION REPORT

Segment 12BW (Full Height Diaphragm)

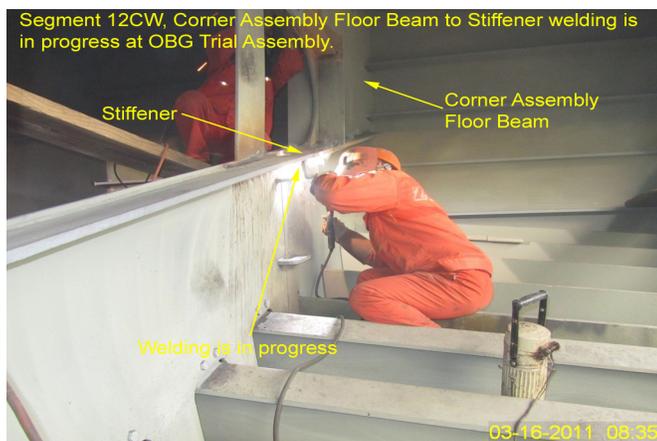
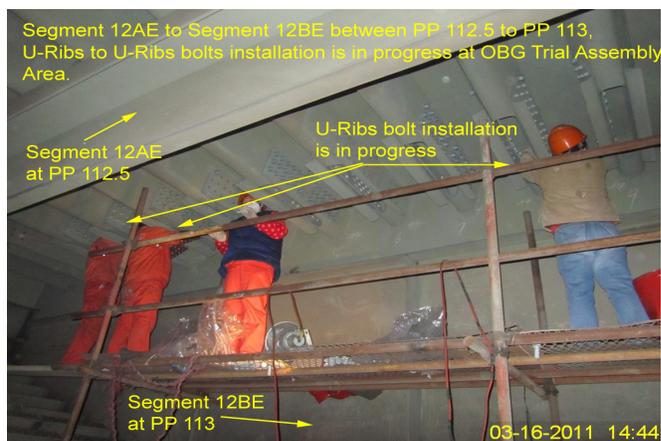
This QA Inspector observed the in-process welding by Shielded Metal Arc Welding (SMAW) process on a Fillet weld. The weld joint was designated as CA3095-001-005. The welder identification was 041713 and observed welding in the 4F (Overhead) position using approved Welding Procedure Specification WPS-B-P-2114-FCM-1. The piece mark was identified as weld connecting the Floor Beam to the Stiffeners, Counter Weight side.

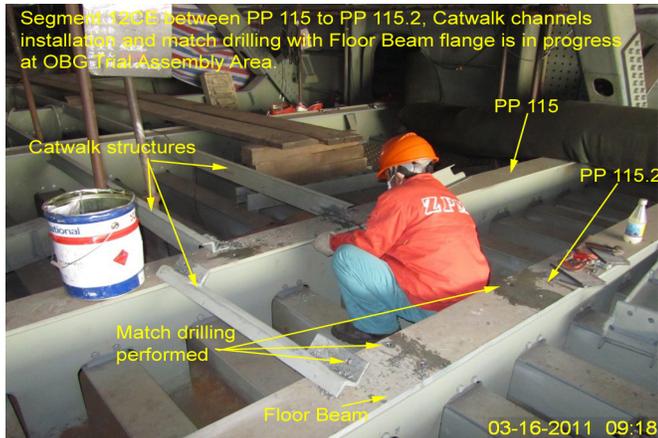
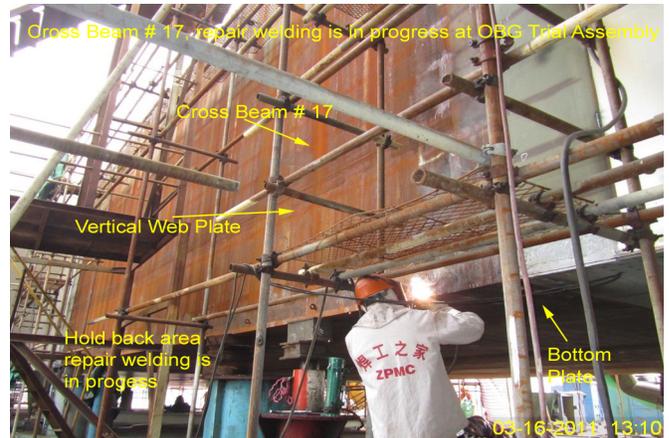
This QA Inspector observed the repair welding by Shielded Metal Arc Welding (SMAW) process on a Complete Joint Penetration (CJP) groove weld. The Weld joint was designated as CB3001A-017-004. The welder identification was 067752 and was observed welding in the 2G (Horizontal) position using approved Welding Procedure Specification WPS-345SMAW-4G(4F)-Repair-FCM-1. The piece mark was identified as weld connecting Bottom Plate to the Vertical Web Plate hold back weld at PP 112. ZPMC performed repair welding in accordance with Welding Repair Report B-WR20414.
