**DEPARTMENT OF TRANSPORTATION**

Contract #: 04-0120F4Cty: SF/ALA Rte: 80 PM: 13.2/13.9File #: 69.28**WELDING INSPECTION REPORT****Resident Engineer:** Siegenthaler, Peter**Address:** 333 Burma Road**City:** Oakland, CA 94607**Report No:** WIR-021788**Date Inspected:** 12-Mar-2011**Project Name:** SAS Superstructure**OSM Arrival Time:** 700**Prime Contractor:** American Bridge/Fluor Enterprises, a JV**OSM Departure Time:** 1900**Contractor:** Zhenhua Port Machinery Company, Ltd (ZPMC), Changxing Island **Location:** Shanghai, China**CWI Name:** Li Yang and Zhu Zhong Hai**CWI Present:** Yes No**Inspected CWI report:** Yes No N/A**Rod Oven in Use:** Yes No N/A**Electrode to specification:** Yes No N/A**Weld Procedures Followed:** Yes No N/A**Qualified Welders:** Yes No N/A**Verified Joint Fit-up:** Yes No N/A**Approved Drawings:** Yes No N/A**Approved WPS:** Yes No N/A**Delayed / Cancelled:** Yes No N/A**Bridge No:** 34-0006**Component:** OBG Trial Assembly**Summary of Items Observed:**

## WELDING INSPECTION REPORT

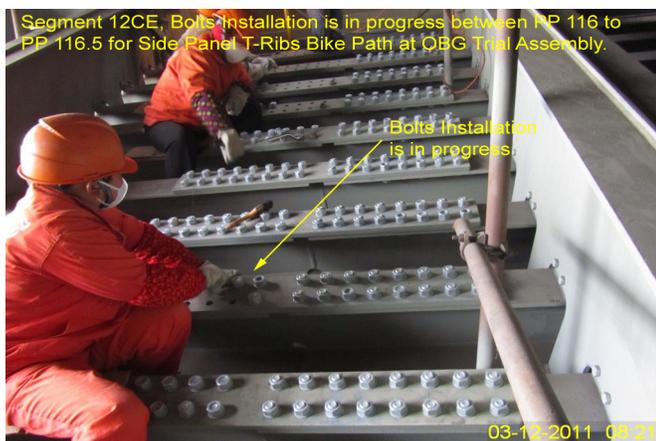
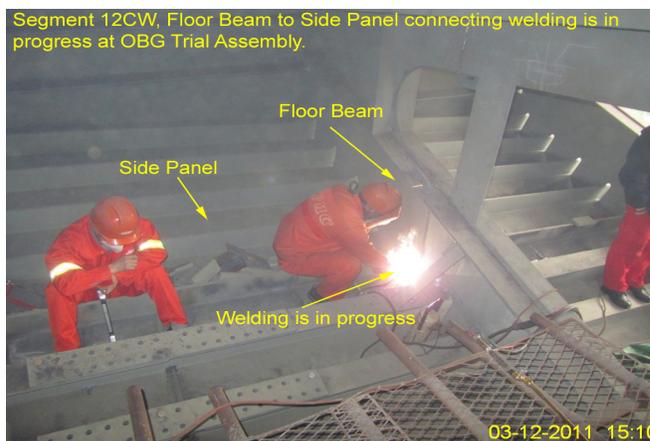
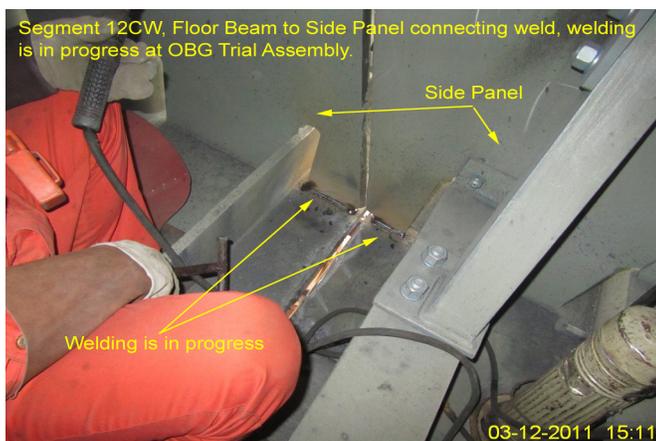
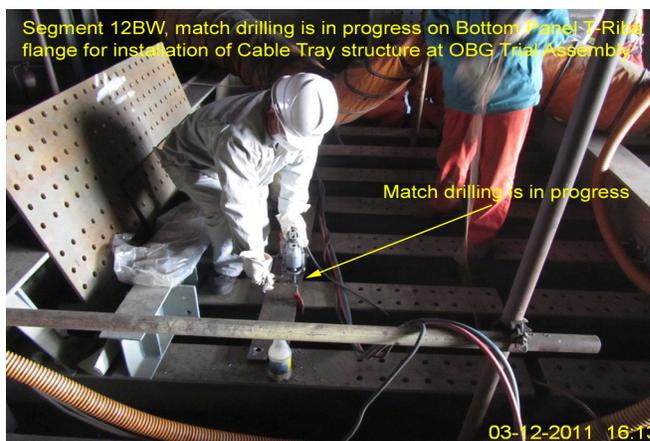
This QA Inspector observed the in-progress welding by Shielded Metal Arc Welding (SMAW) process on a Fillet weld. The Weld joint was designated as Seg3006D-118. The welder identification was 057333 and was observed welding in the 2F (Horizontal) position using approved Welding Procedure Specification WPS-B-P-2112-FCM-1. The piece mark was identified as weld connecting Floor Beam to Side Panel.

installation of Cable Tray structure for Segment 12BW between Panel Points(PP) 114 to PP 114.5.

This QA Inspector observed ZPMC personnel performing bolts installations on Side Panel T-Ribs at Bike Path for Segment 12CE between PP 116 to PP 116.5.
