Quality Assurance and Source Inspection

Contract #: 04-0120F4Cty: SF/ALA Rte: 80 PM: 13.2/13.9File #: 69.28**WELDING INSPECTION REPORT****Resident Engineer:** Siegenthaler, Peter**Address:** 333 Burma Road**City:** Oakland, CA 94607**Report No:** WIR-021856**Date Inspected:** 20-Mar-2011**Project Name:** SAS Superstructure**OSM Arrival Time:** 700**Prime Contractor:** American Bridge/Fluor Enterprises, a JV**OSM Departure Time:** 1900**Contractor:** Zhenhua Port Machinery Company, Ltd (ZPMC), Changxing Island **Location:** Shanghai, China**CWI Name:** Li Yang and Zhu Zhong Hai**CWI Present:** Yes No**Inspected CWI report:** Yes No N/A**Rod Oven in Use:** Yes No N/A**Electrode to specification:** Yes No N/A**Weld Procedures Followed:** Yes No N/A**Qualified Welders:** Yes No N/A**Verified Joint Fit-up:** Yes No N/A**Approved Drawings:** Yes No N/A**Approved WPS:** Yes No N/A**Delayed / Cancelled:** Yes No N/A**Bridge No:** 34-0006**Component:** OBG Trial Assembly**Summary of Items Observed:**

Orthotropic Box Girder (OBG) at Trial Assembly Areas

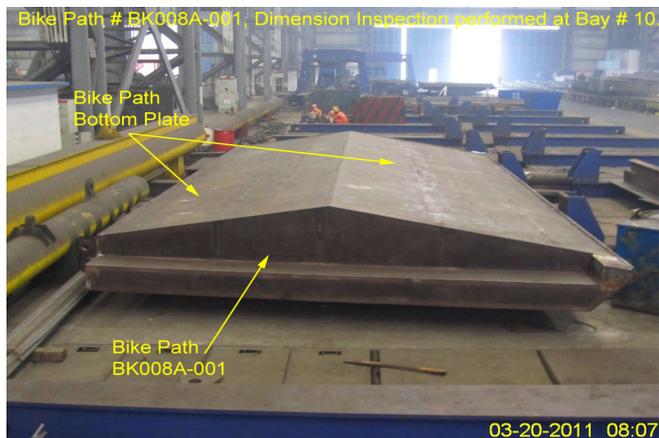
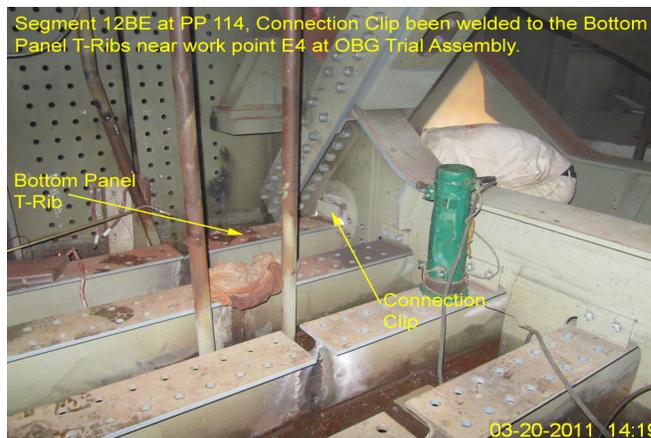
Bike Path at Bay # 10

This QA Inspector performed Dimension Control Inspection on the Bike Path bottom plate for flatness check across the longitudinal butt weld. Flatness check was performed on following mentioned Bike Paths and Bike Path are identified as:

The QA Inspector measured the flatness using 600mm long straight edge across the Butt (CJP) weld and using 1500mm long straight edge between the stiffeners which are plug weld to bottom plate.

Observed flatness within the allowable tolerance.

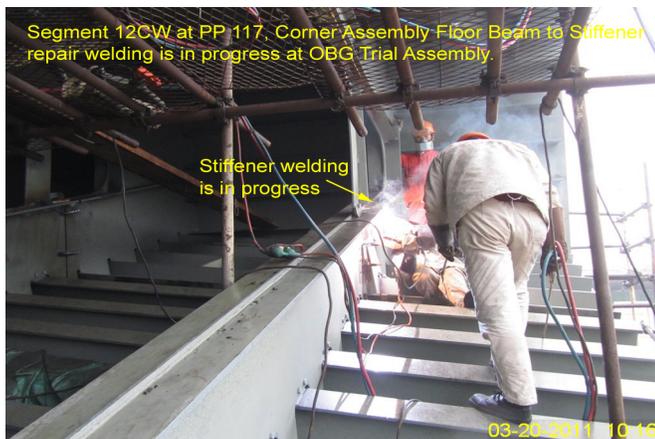
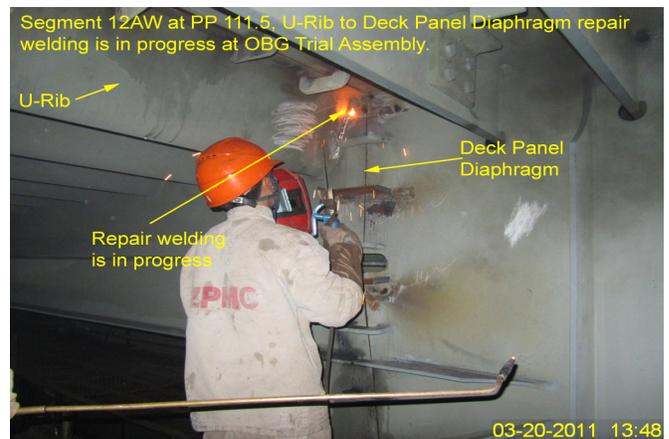
Segment 12CW (Floor Beam to Stiffener weld)

This QA Inspector observed the repair welding by Shielded Metal Arc Welding (SMAW) process on a Fillet weld. The weld joint was designated as FB3097-001-065. The welder identification was 041713 and observed welding in the 4F (Overhead) position using approved Welding Procedure Specification WPS-345-SMAW-4G(4F)-Repair-FCM-1. The piece mark was identified as weld connecting the Floor Beam to the Stiffeners at Corner Assembly, Counter Weight side.

Segment 12BE (Connection Clip)

This QA Inspector observed the repair welding by Shielded Metal Arc Welding (SMAW) process on a Fillet weld. The weld joint was designated as Seg3003-038/039. The welder identification was 037932 and observed welding in the 2F (Horizontal) position using approved Welding Procedure Specification WPS-B-P-2112. The piece mark was identified as weld connecting the Connection Clips on top of Bottom Panel T-Ribs at work point E4.
