DEPARTMENT OF TRANSPORTATION

Contract #: 04-0120F4Cty: SF/ALA Rte: 80 PM: 13.2/13.9File #: 69.28**WELDING INSPECTION REPORT****Resident Engineer:** Siegenthaler, Peter**Address:** 333 Burma Road**City:** Oakland, CA 94607**Report No:** WIR-021899**Date Inspected:** 14-Mar-2011**Project Name:** SAS Superstructure**OSM Arrival Time:** 1500**Prime Contractor:** American Bridge/Fluor Enterprises, a JV**OSM Departure Time:** 300**Contractor:** Zhenhua Port Machinery Company, Ltd (ZPMC), Changxing Island **Location:** Shanghai, China**CWI Name:** Mr. Li Yan Hua**CWI Present:** Yes No**Inspected CWI report:** Yes No N/A**Rod Oven in Use:** Yes No N/A**Electrode to specification:** Yes No N/A**Weld Procedures Followed:** Yes No N/A**Qualified Welders:** Yes No N/A**Verified Joint Fit-up:** Yes No N/A**Approved Drawings:** Yes No N/A**Approved WPS:** Yes No N/A**Delayed / Cancelled:** Yes No N/A**Bridge No:** 34-0006**Component:** OBG**Summary of Items Observed:**

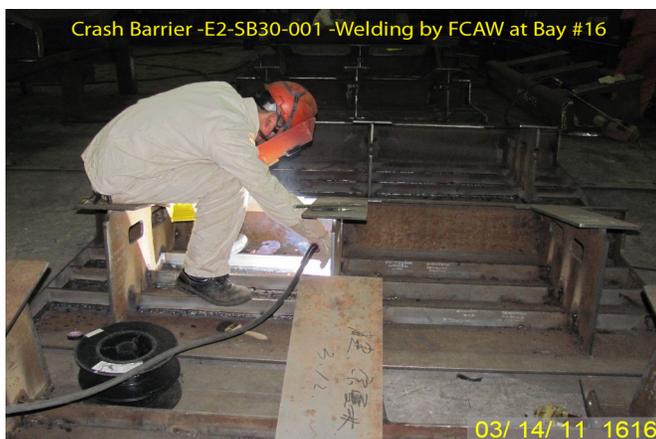
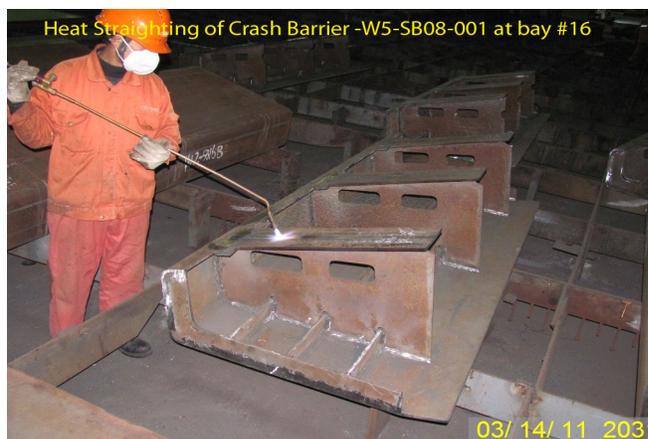
For further information see below pictures:-

Unless otherwise noted, all work observed on this date appeared to be in general compliance with the applicable contract documents.
