DEPARTMENT OF TRANSPORTATION

Contract #: 04-0120F4Cty: SF/ALA Rte: 80 PM: 13.2/13.9File #: 1.28**WELDING INSPECTION REPORT****Resident Engineer:** Siegenthaler, Peter**Address:** 333 Burma Road**City:** Oakland, CA 94607**Report No:** WIR-022028**Date Inspected:** 17-Mar-2011**Project Name:** SAS Superstructure**OSM Arrival Time:** 700**Prime Contractor:** American Bridge/Fluor Enterprises, a JV**OSM Departure Time:** 1730**Contractor:** American Bridge/Fluor Enterprises, a JV**Location:** Job Site

WELDING INSPECTION REPORT

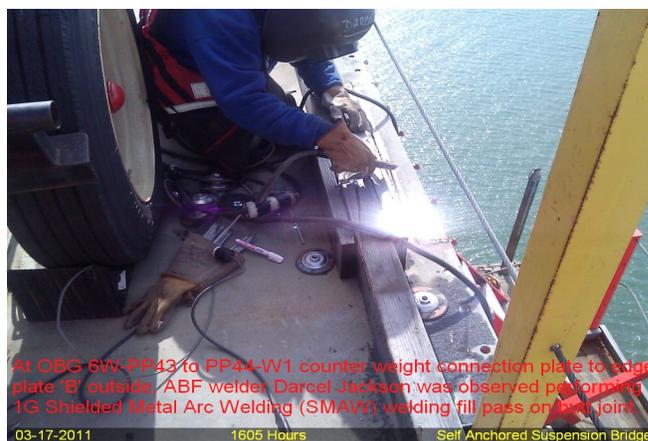
Hwang perform 3G (vertical) Shielded Metal Arc Welding (SMAW) complete joint penetration (CJP) welding root pass to fill pass on the stiffener splice butt joint. The stiffener plates being welded are made of high strength plate material HPS 485W and has a thickness of 30mm. The joint has a double V joint preparation that was welded from one side and after the completion from one side to be back gouged, Non Destructive Testing (NDT) tested using Magnetic Particle Testing (MT) and back welded to the other side. Prior welding, the fit up was inspected and accepted by ABF QC Pat Swain. QA also verified the root gap of less than 7mm and alignment of less than 2mm which deemed acceptable to the contract requirements. The welder was noted using E9018H4R with 1/8" diameter electrode implementing Caltrans approved welding procedure specification (WPS) ABF-WPS-D1. 5-1012-3. The joint being welded was root welded using a ceramic backing. The splice joint was preheated to greater than 200 degrees Fahrenheit using Miller Proheat 35 Induction Heating System heater blanket located at the opposite side of the plate prior/during welding. The QA Inspector noted the ABF QC Steve Mc Connell was on site monitoring the in process preheats and welding parameters. During the shift, QA noted ABF QC Steve Mc Connell was closely monitoring the issuance of E9018H4R electrodes due to its limited exposure time allowed. At the end of the shift, fill pass welding on one side of the butt joint was still continuing and should remain tomorrow.
