**DEPARTMENT OF TRANSPORTATION**

Contract #: 04-0120F4Cty: SF/ALA Rte: 80 PM: 13.2/13.9File #: 69.28**WELDING INSPECTION REPORT****Resident Engineer:** Siegenthaler, Peter**Address:** 333 Burma Road**City:** Oakland, CA 94607**Report No:** WIR-022069**Date Inspected:** 10-Dec-2010**Project Name:** SAS Superstructure**OSM Arrival Time:** 700**Prime Contractor:** American Bridge/Fluor Enterprises, a JV**OSM Departure Time:** 1900**Contractor:** Zhenhua Port Machinery Company, Ltd (ZPMC), Changxing Island **Location:** Shanghai, China**CWI Name:** Qiu Wen**CWI Present:** Yes No**Inspected CWI report:** Yes No N/A**Rod Oven in Use:** Yes No N/A**Electrode to specification:** Yes No N/A**Weld Procedures Followed:** Yes No N/A**Qualified Welders:** Yes No N/A**Verified Joint Fit-up:** Yes No N/A**Approved Drawings:** Yes No N/A**Approved WPS:** Yes No N/A**Delayed / Cancelled:** Yes No N/A**Bridge No:** 34-0006**Component:** OBG**Summary of Items Observed:**

# WELDING INSPECTION REPORT

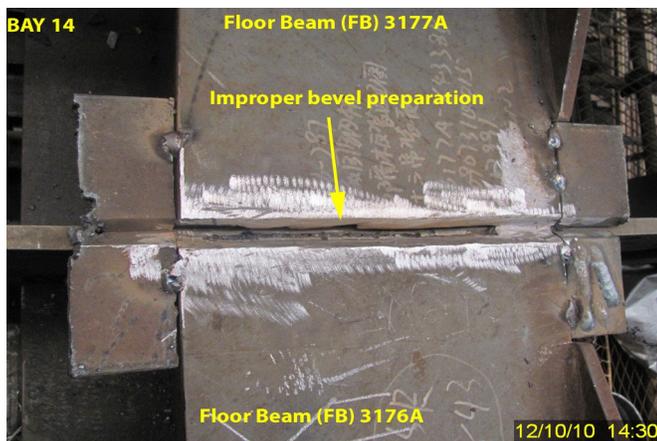
During random in process inspection this QA inspector observed the poor fit up/ improper bevel preparation between two floor beam flanges on the top of longitudinal diaphragm (LD) 3034A. The floor beams are identified as FB3176 and FB3177 at panel point (PP) 118 of segment 13AW. Improper bevel preparation and the base metal of LD 3034A was observed as gouged out during bevel preparation of flanges of FB. This issue has been informed to ZPMC CWI Mr. Qiu Wen and CT lead QA. Mr. Qiu Wen informed this QA that this issue would be corrected in manner compliant with contract documents. Attached photographs provide additional details.
