DEPARTMENT OF TRANSPORTATION

Contract #: 04-0120F4Cty: SF/ALA Rte: 80 PM: 13.2/13.9File #: 69.28**WELDING INSPECTION REPORT****Resident Engineer:** Siegenthaler, Peter**Address:** 333 Burma Road**City:** Oakland, CA 94607**Report No:** WIR-022074**Date Inspected:** 27-Dec-2010**Project Name:** SAS Superstructure**OSM Arrival Time:** 700**Prime Contractor:** American Bridge/Fluor Enterprises, a JV**OSM Departure Time:** 1900**Contractor:** Zhenhua Port Machinery Company, Ltd (ZPMC), Changxing Island **Location:** Shanghai, China**CWI Name:** Qiu Wen**CWI Present:** Yes No**Inspected CWI report:** Yes No N/A**Rod Oven in Use:** Yes No N/A**Electrode to specification:** Yes No N/A**Weld Procedures Followed:** Yes No N/A**Qualified Welders:** Yes No N/A**Verified Joint Fit-up:** Yes No N/A**Approved Drawings:** Yes No N/A**Approved WPS:** Yes No N/A**Delayed / Cancelled:** Yes No N/A**Bridge No:** 34-0006**Component:** OBG**Summary of Items Observed:**

OBG Seg 14W

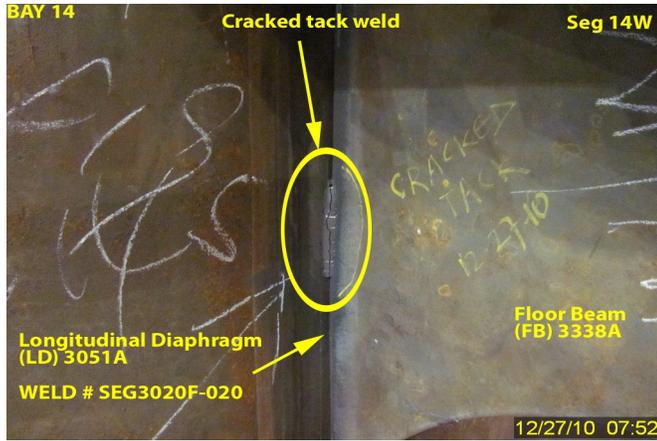
During random in process inspection of OBG member identified as segment 14W this QA observed a cracked tack weld on weld joint identified as SEG3020F-020 [Floor Beam (FB) 3338A to Longitudinal Diaphragm (LD) 3051A, fillet weld at panel points (PP) 128]. This QA marked the cracked tack and informed ZPMC Quality Control (QC) identified as Mr. Qiu Wen of this issue. Mr. Qiu Wen informed this QA that the cracked tack would be corrected in a manner compliant with the contract documents. Attached photograph provide additional detail.
