DEPARTMENT OF TRANSPORTATION

Quality Assurance and Source Inspection

Contract #: 04-0120F4Cty: SF/ALA Rte: 80 PM: 13.2/13.9File #: 1.28**WELDING INSPECTION REPORT****Resident Engineer:** Siegenthaler, Peter**Address:** 333 Burma Road**City:** Oakland, CA 94607**Report No:** WIR-022203**Date Inspected:** 29-Mar-2011**Project Name:** SAS Superstructure**OSM Arrival Time:** 700**Prime Contractor:** American Bridge/Fluor Enterprises, a JV**OSM Departure Time:** 1530**Contractor:** American Bridge/Fluor Enterprises, a JV**Location:** Job Site**CWI Name:** G. Ehram**CWI Present:** Yes No**Inspected CWI report:** Yes No N/A**Rod Oven in Use:** Yes No N/A**Electrode to specification:** Yes No N/A**Weld Procedures Followed:** Yes No N/A**Qualified Welders:** Yes No N/A**Verified Joint Fit-up:** Yes No N/A**Approved Drawings:** Yes No N/A**Approved WPS:** Yes No N/A**Delayed / Cancelled:** Yes No N/A**Bridge No:** 34-0006**Component:** Orthotropic Box Girders**Summary of Items Observed:**

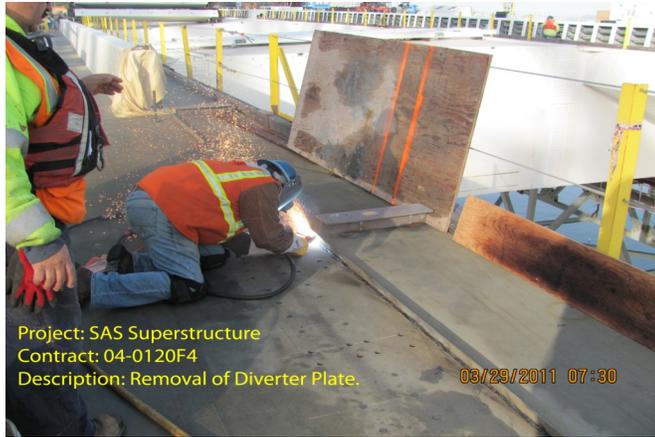
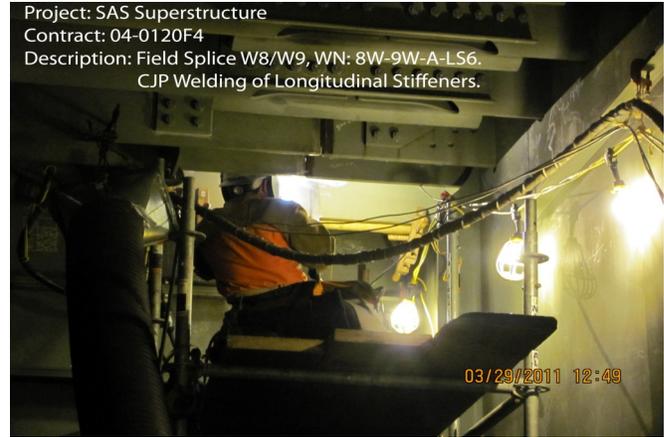
The digital photographs below illustrate some of the work observed during this scheduled shift.
