**DEPARTMENT OF TRANSPORTATION**

Contract #: 04-0120F4Cty: SF/ALA Rte: 80 PM: 13.2/13.9File #: 69.28**WELDING INSPECTION REPORT****Resident Engineer:** Siegenthaler, Peter**Address:** 333 Burma Road**City:** Oakland, CA 94607**Report No:** WIR-022214**Date Inspected:** 31-Mar-2011**Project Name:** SAS Superstructure**OSM Arrival Time:** 700**Prime Contractor:** American Bridge/Fluor Enterprises, a JV**OSM Departure Time:** 1700**Contractor:** Zhenhua Port Machinery Company, Ltd (ZPMC), Changxing Island **Location:** Shanghai, China**CWI Name:** Zhu Zhong Hai**CWI Present:** Yes No**Inspected CWI report:** Yes No N/A**Rod Oven in Use:** Yes No N/A**Electrode to specification:** Yes No N/A**Weld Procedures Followed:** Yes No N/A**Qualified Welders:** Yes No N/A**Verified Joint Fit-up:** Yes No N/A**Approved Drawings:** Yes No N/A**Approved WPS:** Yes No N/A**Delayed / Cancelled:** Yes No N/A**Bridge No:** 34-0006**Component:** OBG Segments**Summary of Items Observed:**

# WELDING INSPECTION REPORT

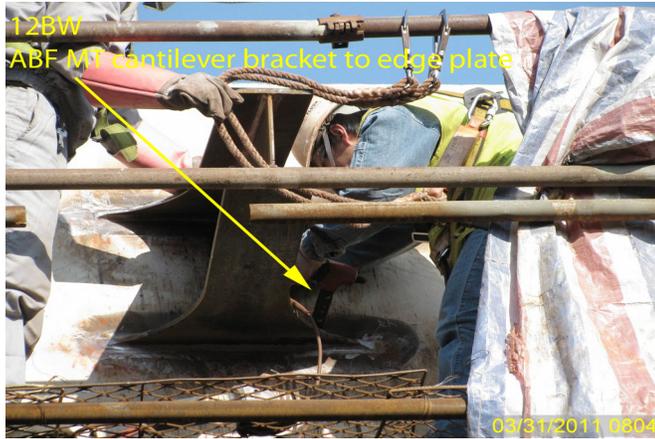
This QA Inspector observed ABF personnel performing Magnetic Particle Testing on the Cantilever Bracket to

Edge Plate connection at top and bottom flange and web.
