DEPARTMENT OF TRANSPORTATION

Contract #: 04-0120F4Cty: SF/ALA Rte: 80 PM: 13.2/13.9File #: 69.28**WELDING INSPECTION REPORT****Resident Engineer:** Siegenthaler, Peter**Address:** 333 Burma Road**City:** Oakland, CA 94607**Report No:** WIR-022220**Date Inspected:** 30-Mar-2011**Project Name:** SAS Superstructure**OSM Arrival Time:** 700**Prime Contractor:** American Bridge/Fluor Enterprises, a JV**OSM Departure Time:** 1900**Contractor:** Zhenhua Port Machinery Company, Ltd (ZPMC), Changxing Island **Location:** Shanghai, China**CWI Name:** Li Yang and Zhu Zhong Hai**CWI Present:** Yes No**Inspected CWI report:** Yes No N/A**Rod Oven in Use:** Yes No N/A**Electrode to specification:** Yes No N/A**Weld Procedures Followed:** Yes No N/A**Qualified Welders:** Yes No N/A**Verified Joint Fit-up:** Yes No N/A**Approved Drawings:** Yes No N/A**Approved WPS:** Yes No N/A**Delayed / Cancelled:** Yes No N/A**Bridge No:** 34-0006**Component:** OBG Trial Assembly**Summary of Items Observed:**

Orthotropic Box Girder (OBG) at Trial Assembly Areas

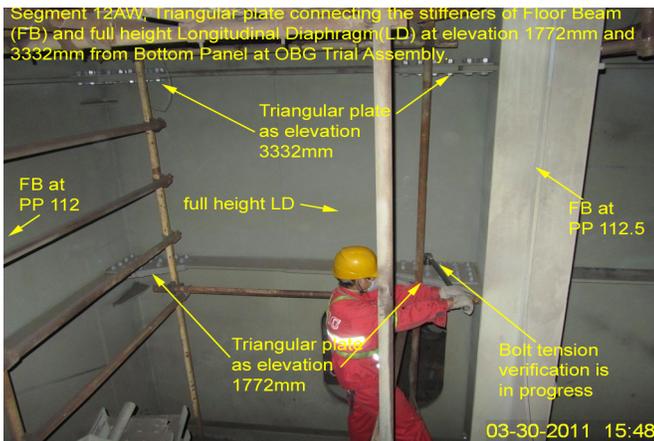
Segment 12AW (Triangular Plate)

This QA Inspector witnessed final bolt tension verification on bolts connecting triangular plate connecting the stiffeners of Floor Beam and full height Longitudinal Diaphragm at elevations 1772 mm and at 3332mm from Bottom Panel at work point W4 (Cross Beam side) and at work point W3 (Counter Weight side) at Panel Points (PP) 115.5 (east side), PP 112 (east and west side), 112.5 (east and west side) for Segment 12AW. Inspected the bolt tensioning on a random basis and found the tension to be in general compliance. Inspection was performed against the Notification No. 00634 Dated Mar 30, 2011.

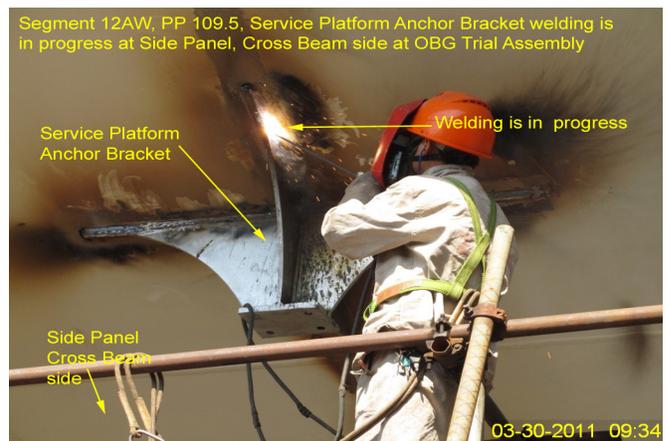
Segment 12AW(Service Platform Anchor Bracket)

This QA Inspector observed the in-process welding by Shielded Metal Arc Welding (SMAW) process on a Complete Joint Penetration (CJP) weld. The weld joint was designated as Seg3004AD-006. The welder identification was 046709 and was observed welding in the 4G (Overhead) position using approved Welding Procedure Specification WPS-B-P-2214-Tc-U4b-FCM-1. The piece mark was identified as Service Platform Anchor Bracket welded at Edge Panel at PP 109.5, Cross Beam side.
