**DEPARTMENT OF TRANSPORTATION**

Contract #: 04-0120F4Cty: SF/ALA Rte: 80 PM: 13.2/13.9File #: 69.28**WELDING INSPECTION REPORT****Resident Engineer:** Siegenthaler, Peter**Address:** 333 Burma Road**City:** Oakland, CA 94607**Report No:** WIR-022259**Date Inspected:** 29-Mar-2011**Project Name:** SAS Superstructure**OSM Arrival Time:** 700**Prime Contractor:** American Bridge/Fluor Enterprises, a JV**OSM Departure Time:** 1900**Contractor:** Zhenhua Port Machinery Company, Ltd (ZPMC), Changxing Island **Location:** Shanghai, China**CWI Name:** Mr. Shi zhi**CWI Present:** Yes No**Inspected CWI report:** Yes No N/A**Rod Oven in Use:** Yes No N/A**Electrode to specification:** Yes No N/A**Weld Procedures Followed:** Yes No N/A**Qualified Welders:** Yes No N/A**Verified Joint Fit-up:** Yes No N/A**Approved Drawings:** Yes No N/A**Approved WPS:** Yes No N/A**Delayed / Cancelled:** Yes No N/A**Bridge No:** 34-0006**Component:** Orthotropic Box Girder (OBG)**Summary of Items Observed:**

OBG Trial Assembly open yard.

Segment: 13AW

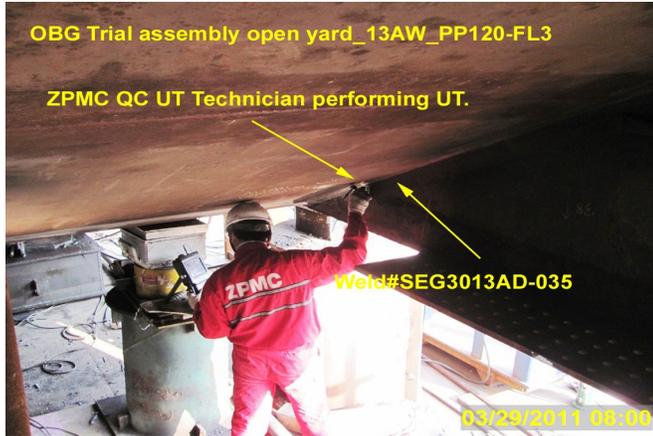
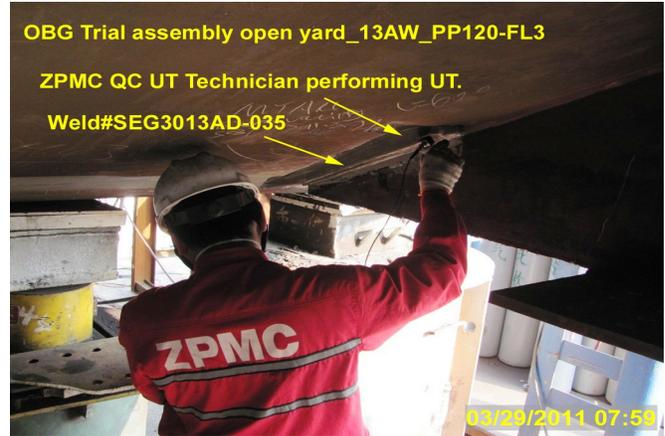
ZPMC QC UT Technician performing Ultrasonic Testing for the weld joint identified as SEG3013AD-035 at Panel point 120 FL3 area. See attached photos for further information.
