DEPARTMENT OF TRANSPORTATION

Contract #: 04-0120F4Cty: SF/ALA Rte: 80 PM: 13.2/13.9File #: 69.28**WELDING INSPECTION REPORT****Resident Engineer:** Siegenthaler, Peter**Address:** 333 Burma Road**City:** Oakland, CA 94607**Report No:** WIR-022296**Date Inspected:** 14-Mar-2011**Project Name:** SAS Superstructure**OSM Arrival Time:** 700**Prime Contractor:** American Bridge/Fluor Enterprises, a JV**OSM Departure Time:** 1900**Contractor:** Zhenhua Port Machinery Company, Ltd (ZPMC), Changxing Island **Location:** Shanghai, China**CWI Name:** Xu Le Feng**CWI Present:** Yes No**Inspected CWI report:** Yes No N/A**Rod Oven in Use:** Yes No N/A**Electrode to specification:** Yes No N/A**Weld Procedures Followed:** Yes No N/A**Qualified Welders:** Yes No N/A**Verified Joint Fit-up:** Yes No N/A**Approved Drawings:** Yes No N/A**Approved WPS:** Yes No N/A**Delayed / Cancelled:** Yes No N/A**Bridge No:** 34-0006**Component:** OBG & TOWER Components**Summary of Items Observed:**

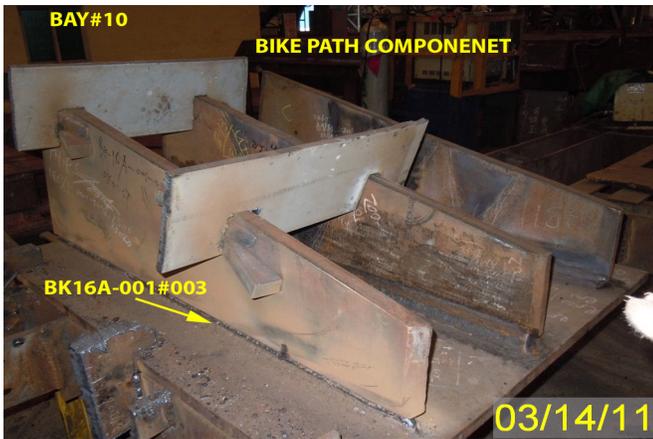
Weld joint #003 located on Bike path BK16A-001. Welder is identified as 040365. ZPMC Quality Control (QC) Inspector is identified as Sun Zi Wang. The welding variables recorded by QC appeared to comply with the WPS-B-P-2212-Tc-U4c. (See attached photo)

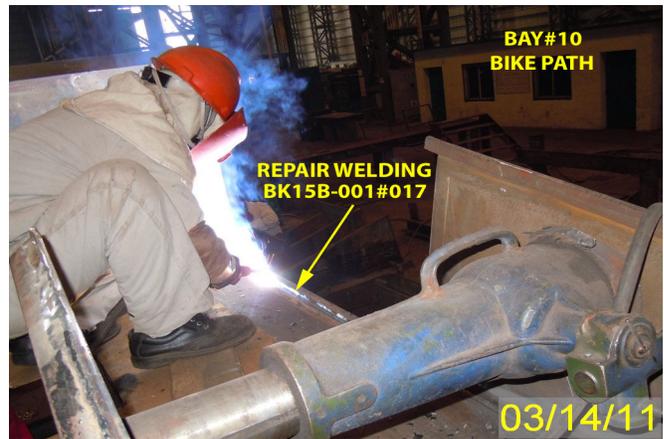
Repair welding of a weld joint #17 located on Bike Path BK15B-001 as per the weld repair report # B-WR20395. Welder is identified as 040533. ZPMC Quality Control (QC) Inspector is identified as Sun Zi Wang. The welding variables recorded by QC appeared to comply with the WPS-345-FCAW-1G (1F)-ESAB-REPAIR. (See attached photo)
